Road Safety Audit – Clevedon Active Travel Scheme

Stage: 3

Location: B3130 Hill Road area, Clevedon, North Somerset

Site: Cycle Lanes, One-Way Roads and 20mph Speed Limit

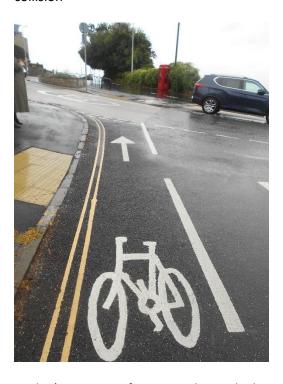
It is not clear to westbound cyclists emerging from Seavale Road that The Beach is one way northbound. Cyclists who turn left here towards Elton Road will be in conflict with vehicles turning from Elton Road into The Beach (especially those turning left in), increasing the risk of a head-on collision

Cyclist's view west from Seavale Road. There is nothing to prevent a cycle turning left into oncoming traffic

Recommendation – Provide a banned left turn roundel sign on the reverse of the southern 'oneway with cycle contraflow' sign at the west end of Seavale Road

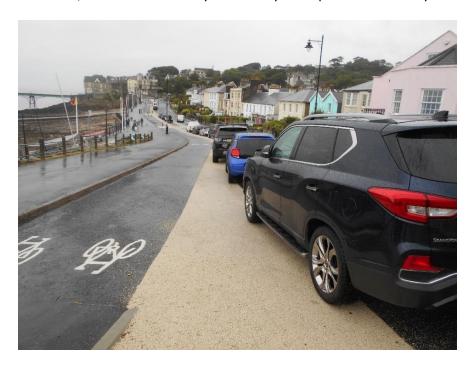
It was noted that some vehicles park over the buff strip which separates parked vehicles from the cycle lane. Those that do so are at risk of opening nearside doors into the path of an oncoming (southbound) cycle

Looking north along The Beach, showing vehicles parked over buff strip, and frequency of existing cycle symbols

Recommendation – Introduce individual parking bay markings to increase driver understanding of the layout, and encourage drivers to park away from the buffer zone. Establish the level of any potential conflicts, by use a video monitor to capture long periods of activity, including busy sunny weekends, when there are likely to be many more pedestrians and cyclists

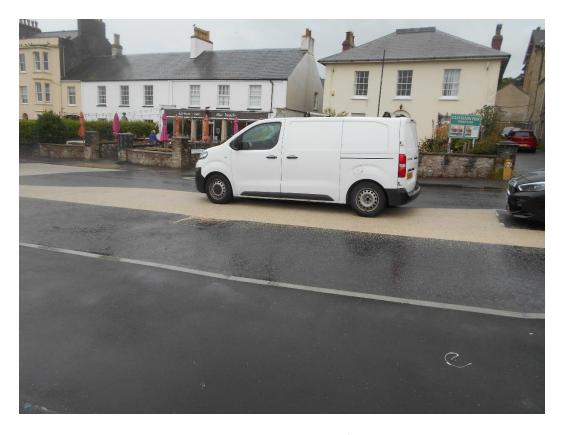
Vehicles parked across the vehicle dropped kerb providing access to the sailing club/ice cream van bay will cause problems for vehicles accessing or exiting this area, resulting in possible dangerous manoeuvres increasing the risk of collisions

Poorly parked vehicle obstructing access to sailing club/ice cream van bay

Recommendation – Introduce formal waiting and loading restrictions marked by yellow lines and kerbside tics, and follow up with enforcement

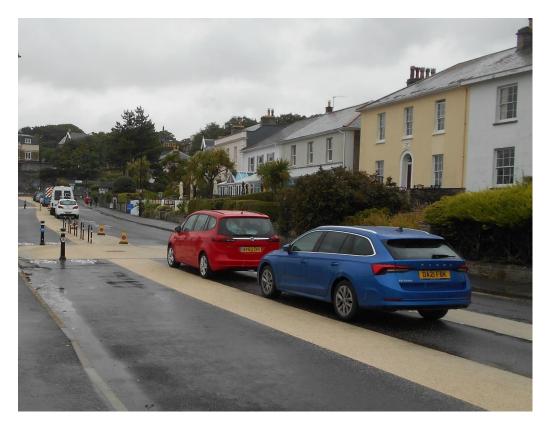
Vehicles parked immediately to the south of the crossing point obstruct intervisibility between northbound drivers and pedestrians crossing west to east, increasing the risk of vehicle/pedestrian collisions

Recommendation – Remove one parking bay (where the red car is in the above photo) and install waiting restrictions

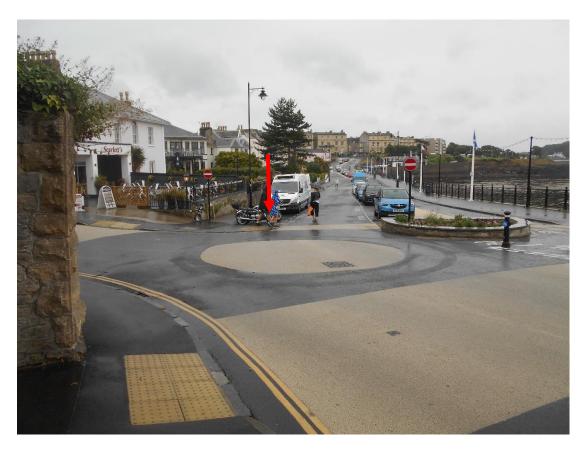
There is evidence that vehicles southbound on Marine Parade have entered, or tried to enter, The Beach, in contravention of the No Entry signs. Site observations suggested that the current signs are too small, and too widely spaced, making the No Entry less clear than it could be. The darkness inspection also showed that these signs are quite inconspicuous in darkness, even when viewed with a vehicle's headlights, especially against a background of the promenade illuminations

View south towards The Beach from Marine Parade

Recommendation – Provide larger No Entry signs and move the eastern sign to the western nose of the buildout (as arrowed above) to form a gateway. Provide illumination to both signs. Provide Turn Left and Turn Right arrows on Marine Parade and Alexandra Road approaches to the 'doughnut' respectively. Introduce a 'No Entry' legend, or a 20 roundel facing northbound traffic, on The Beach between the No Entry signs

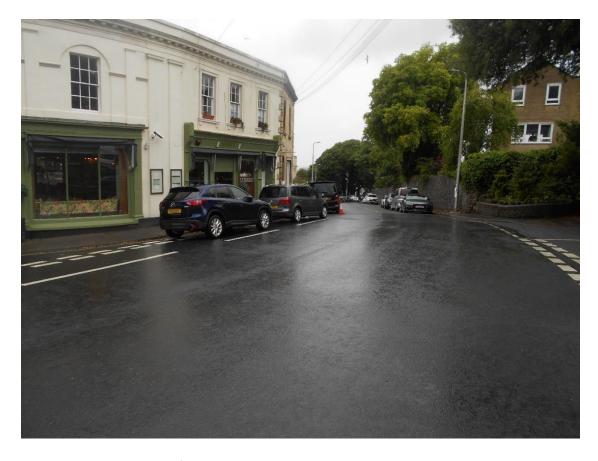
To the west of Copse Road there is no centre line on Hill Road, which may suggest to eastbound drivers that they are on a one way eastbound road. Eastbound drivers were seen to drive along the centre of the road, where they would be in conflict with a vehicle turning left out of Copse Road, increasing the risk of head-on collisions

Looking west on Hill Road from the Copse Road junction

Recommendation – Extend the existing centre line on Hill Road to a point opposite the centre line of Copse Road

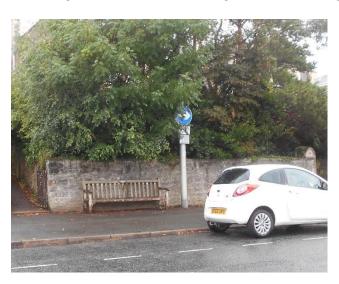
The sign to diagram 616 (turn right only) opposite Gardens Road is partly obscured by vegetation, increasing the risk of a driver turning left into oncoming traffic

Recommendation – Remove vegetation in this area

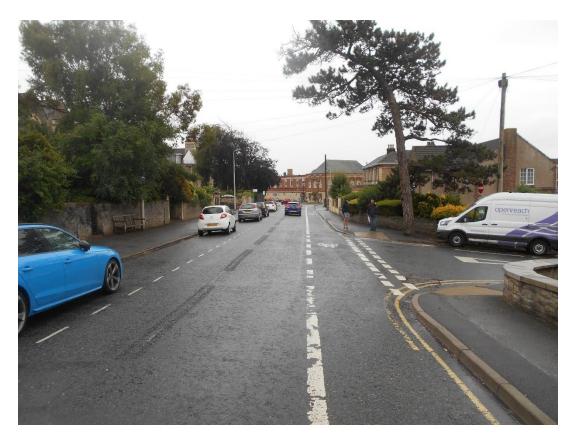
The No Entry signs on Gardens Road are set back a fair way, so that it is not immediately apparent to a driver southbound on Bellevue Road that they cannot turn right into Gardens Road. Following recommendations in the previous stage 3 audit, a 'No Right Turn' sign has been erected prior to the junction, however there is a possibility that drivers may miss this sign and turn right, increasing the risk of a head-on collision

View south on Bellevue Road with Gardens Road on right

Recommendation – Introduce a 'Straight Ahead' arrow on Bellevue Road opposite Gardens Road

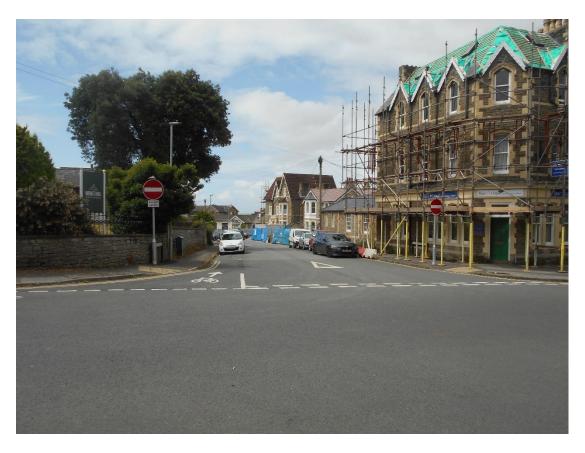
Complaints from residents of Woodlands Road suggest drivers are contravening the No Entry signs at the junction with Alexandra Road, increasing the risk of head-on collisions with oncoming vehicles

Looking into Woodlands Road from Alexandra Road

Recommendation – Install 'NO ENTRY' carriageway markings across the mouth of Woodlands Road

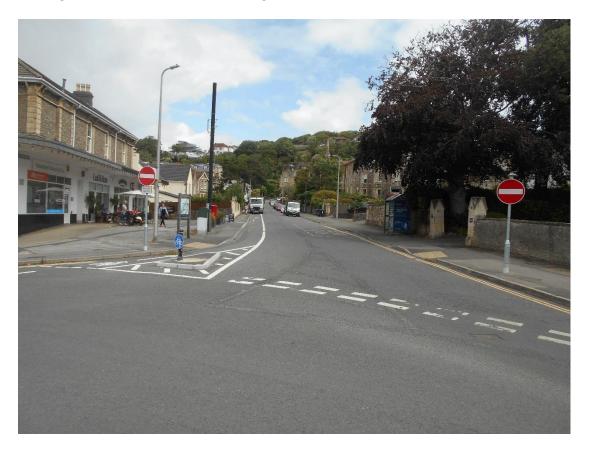
The No Entry signs here are very widely spaced, such that drivers may mistakenly turn into Bellevue Road against the flow of traffic, increasing the risk of head-on collisions

Recommendation – Install 'NO ENTRY' carriageway markings across the mouth of Bellevue Road
