Worlebury Camp Hillfort

Conservation Management Plan
2018 – 2025

Worlebury Camp is a large Iron Age hillfort located on a limestone promontory to the north of Weston-super-Mare. It sits at the western spur of Worlebury Hill covering an area of approximately 10 hectares, within the larger Weston Woods (130 hectares). It is afforded the highest protection for a heritage asset in England, as a Scheduled Monument (National Heritage List for England number: 1011260).

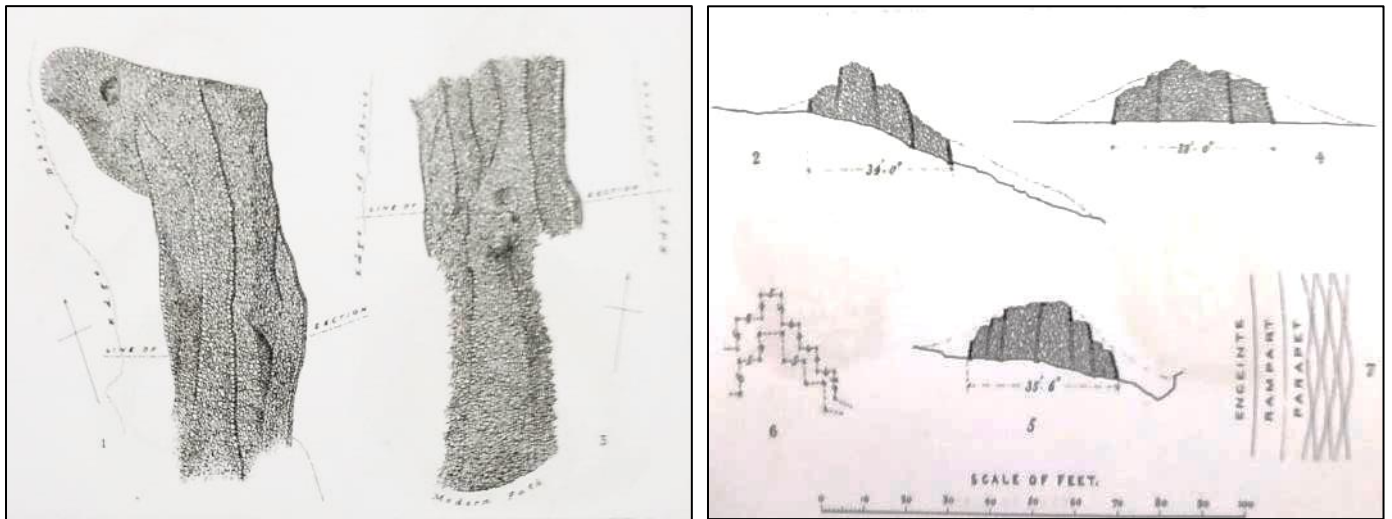
At the eastern end of the hillfort lies a multivallate system of defences in the form of seven banks and ditches. The material for the banks/walls comprises the excavated material from the ditches. The ramparts become smaller in size as you move away from the interior of the hillfort, with the innermost bank measuring 10m wide and c1.5m high. The smaller banks and ditches are cut directly out of the

limestone bedrock. This was the only area that did not benefit from natural defensive slopes or cliffs, and as such, this defensive system was constructed. The maximum width of these ramparts is approximately 100m.

Figures 5 & 6: Plans of walls/ramparts (Dymond & Tomkins, 1886)

Dymond provides a detailed analysis of the construction of the ramparts, stating that they comprised a ‘massive wall comprised of loose stones, faced on both sides with dry walling’ (Dymond, 1886; Cotswold Archaeology, 2018).

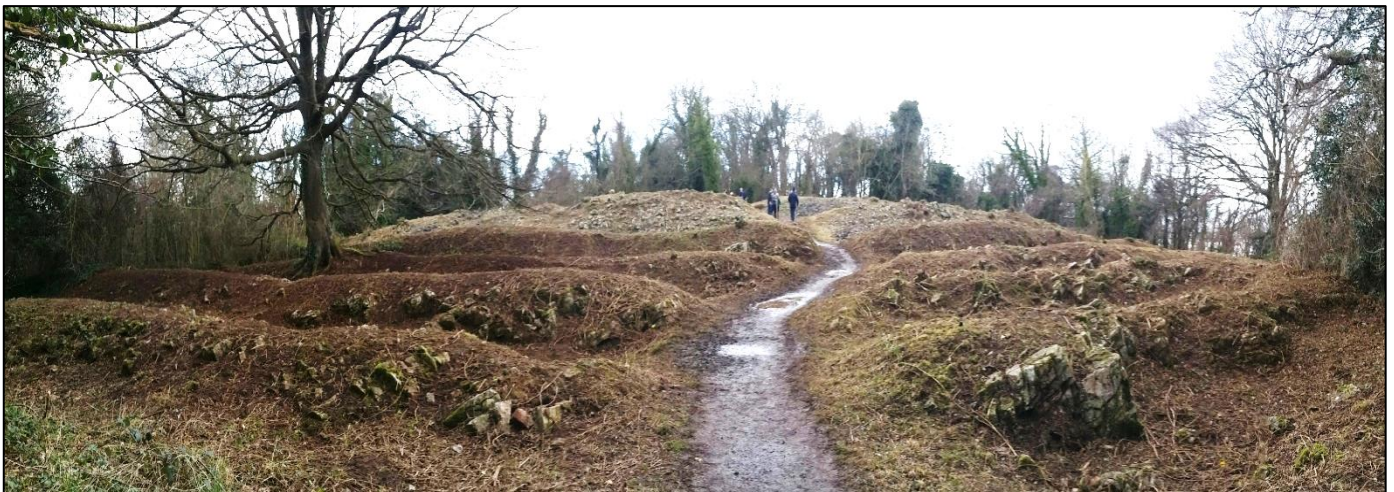
Figure 7: Eastern ramparts after vegetation clearance showing 1930s path (January 2018)

It must be noted that the pathway through the eastern ramparts is of modern construction (fig.7). The modern entrance, located through the centre of the eastern multivallate defences was constructed in the late 1930s. The path was “cut through the encampment, while deep dips have been neatly bridged” (Anon, 1939). Figure 8 is an image from a newspaper article from May 1939 showing workmen from the council engaged in constructing a pathway from Worlebury Cottage to the Sky

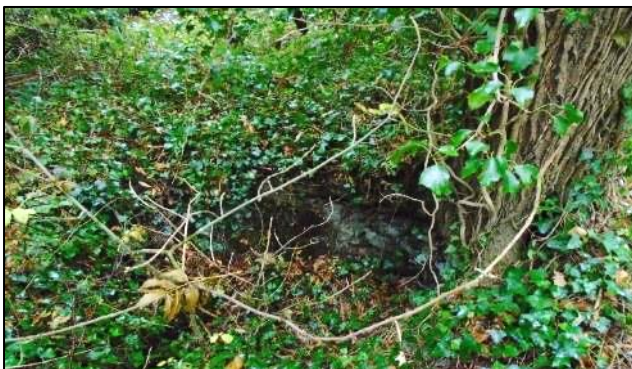
Figure 17: Pit engulfed by ivy, with roots of medium-sized tree enveloping side of pit

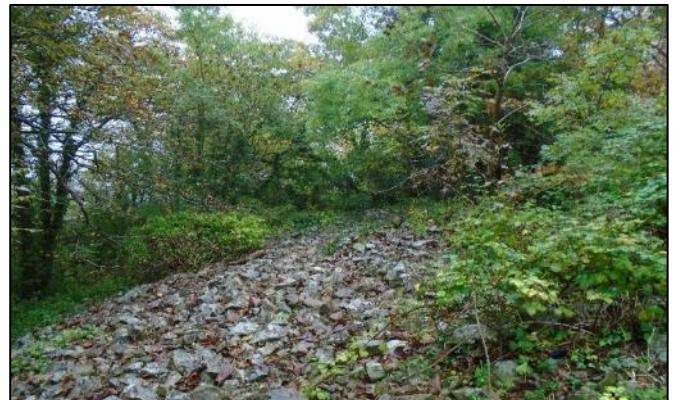
Figure 18: Trees and vegetation along southern rampart

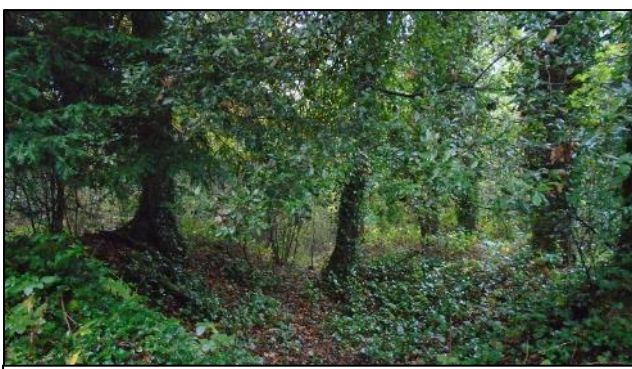
Figure 19: Trees and vegetation along ramparts. Roots here are causing damage to the rampart material

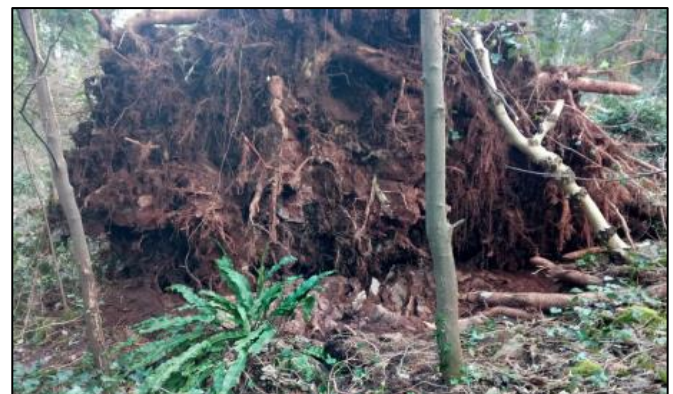
Figure 20: Damage caused by a tree throw

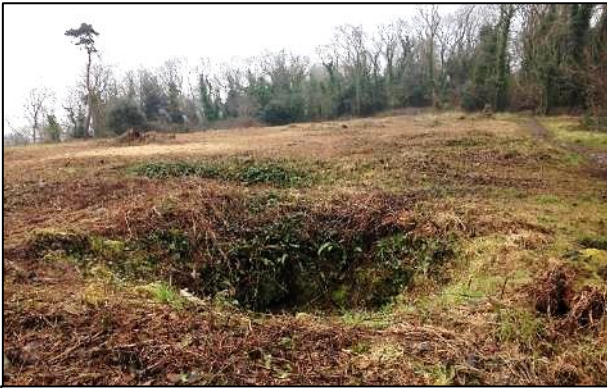
Figure 21: Glade after vegetation cut - January 2017

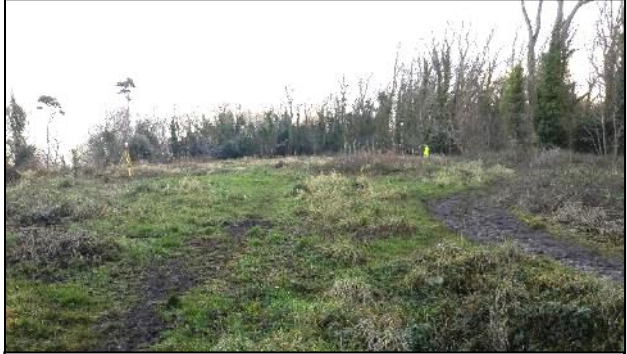
Figure 22: Glade after further removal of vegetation – January 2018

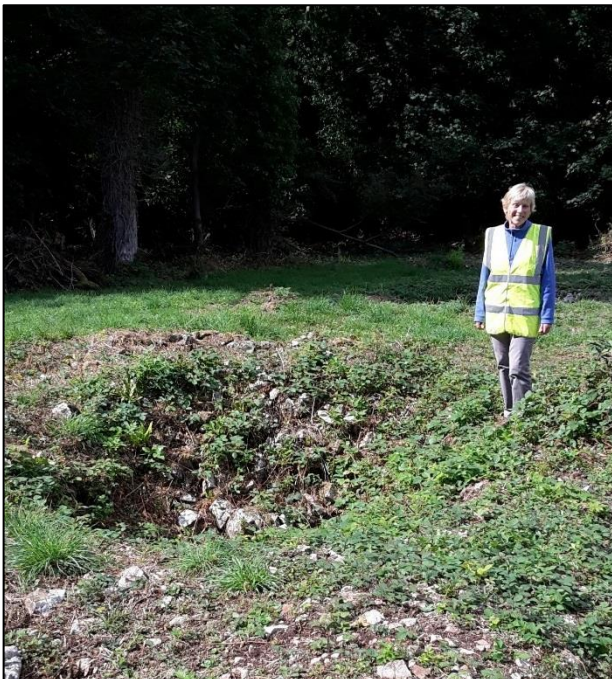
Figure 23: Pit cleared of brambles (Worlebury Hillfort Group, August 2018)

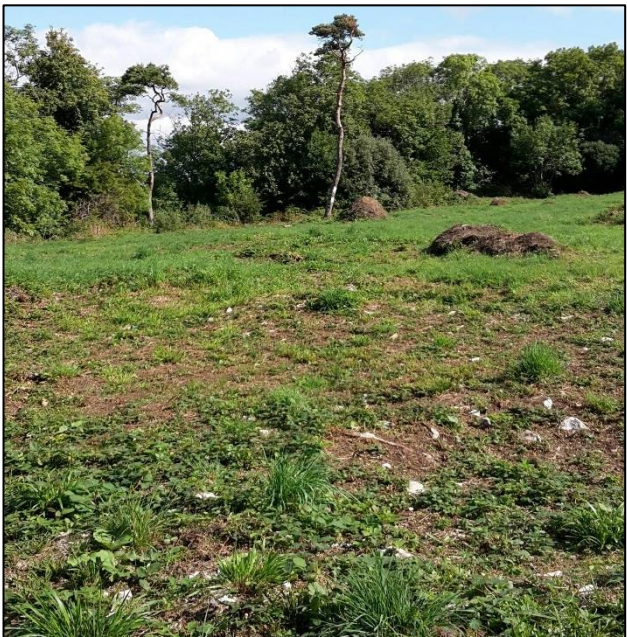
Figure 24: Glade showing continued clearance of brambles, etc., resulting in re-establishment of limestone grassland – Summer 2018

Clearance of vegetation will be easier through the clear-felling of trees, due to improved access to previously inaccessible areas. This will also allow for the re-establishment of limestone grassland across the majority of the interior of the hillfort.

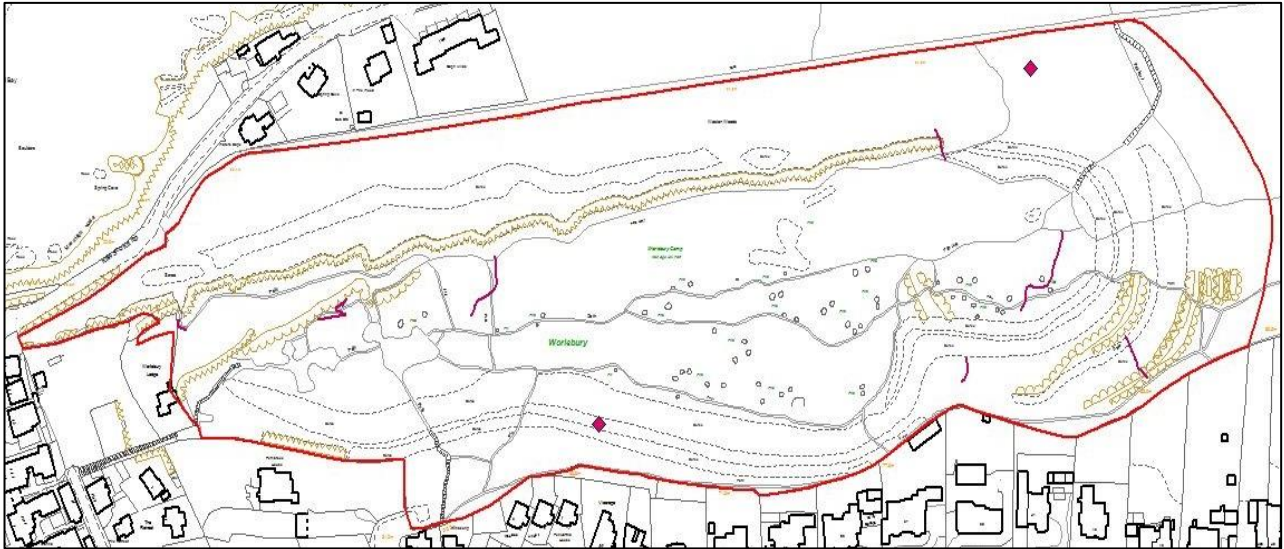
Figure 25: Recorded locations of erosion

Erosion is defined in the condition survey as 'unofficial footpaths'. These are located where visitors stray from more formal routes.

with research projects					
Objective	Detail	Method	Measure	Timing / Date	Who	
Objective 6: To improve access to, and within the hillfort						
6.1	Footpaths	PROW that crosses the hillfort is in bad state of repair – severe erosion resulting in protruding rocks and tree roots, causing potential risk to visitors	Reinstate footpath to improve accessibility and prevent further erosion Method to be agreed with Historic England	Improved footpaths/ access	Spring / Summer 2021	NSC / appointed contractors / Historic England

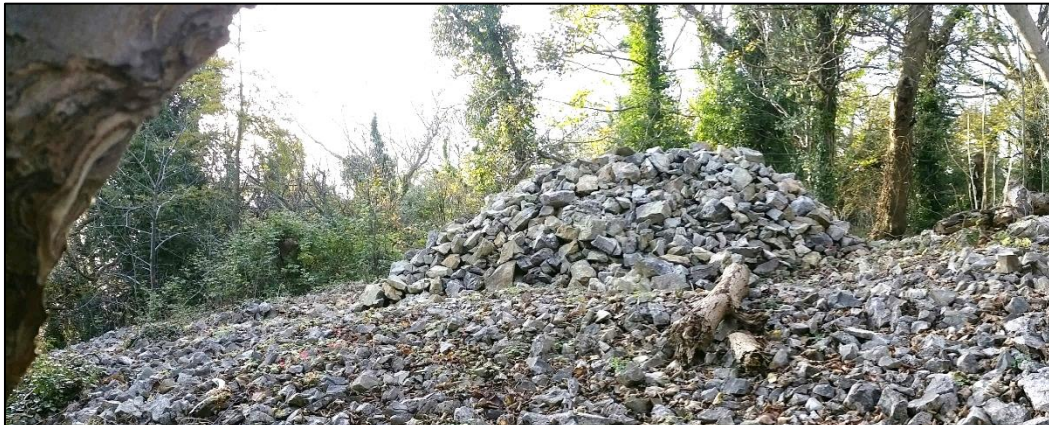
Stones that have been moved from their original locations and creation of features such as the cairn in fig.27 and shelters/play-forts in figs. 28, 29 & 30 are regarded as heritage crime. The most significant identified instance of this form of heritage crime is located at the original entrance to the hillfort, at the top of the southern ramparts, and was defined in the condition survey as 'severe damage'. This feature sits almost 2 metres high and 4m in diameter. The main concern with this type of damage to the hillfort is that it causes irreparable damage to the monument's form and structure.

Figure 27: Movement of stones resulting in creation of modern cairn

1.8	Prevent creation of cairns and play-forts	Features created from rampart material	Dismantle features in line with method statement accepted as part of Scheduled Monument Consent for general maintenance of hillfort. Educate visitors of impact of creating features.	Condition of Scheduled Monument Consent to be discharged / Once features are dismantled, no further structures created /	Ongoing	NSC / volunteers / Civic Society

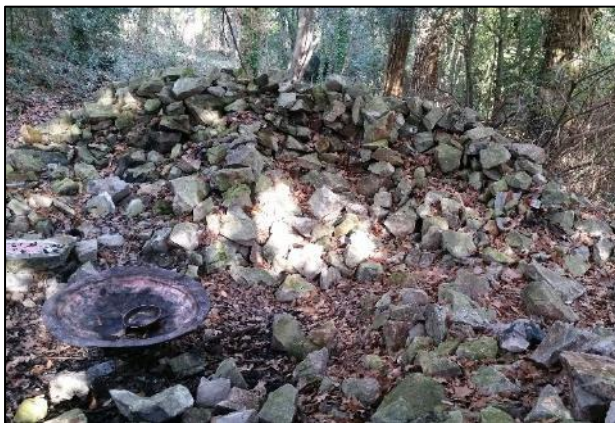
Other areas of heritage crime through removal of stones include shelters and play-forts, and these are mostly found along the southern ramparts, and also within the eastern rampart complex.

Figure 28: Example of shelter created using rampart material on southern slopes

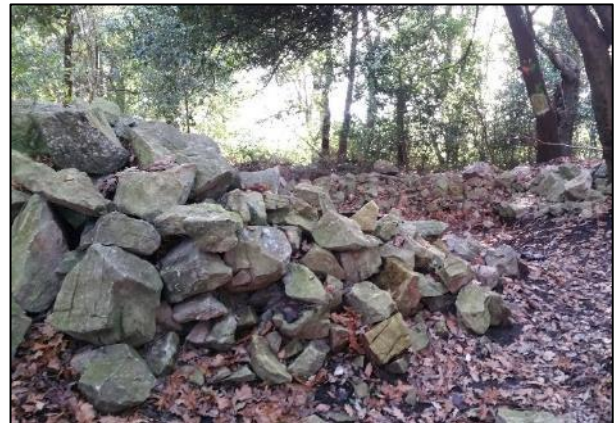
Figure 29: Example of shelter created using rampart material on southern slopes

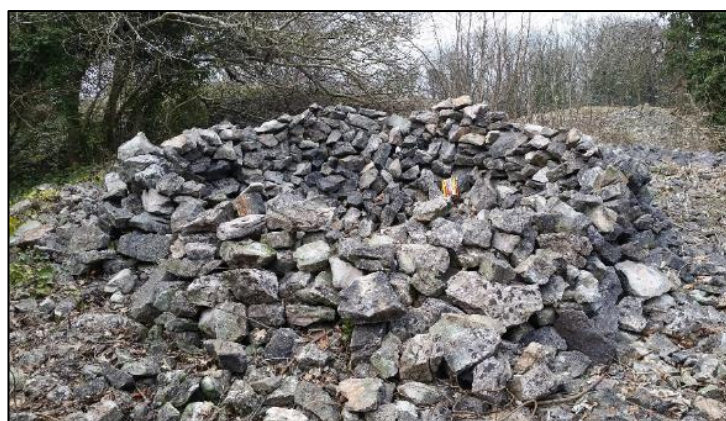
Figure 30: Example of shelter/play-fort created using rampart material on eastern ramparts

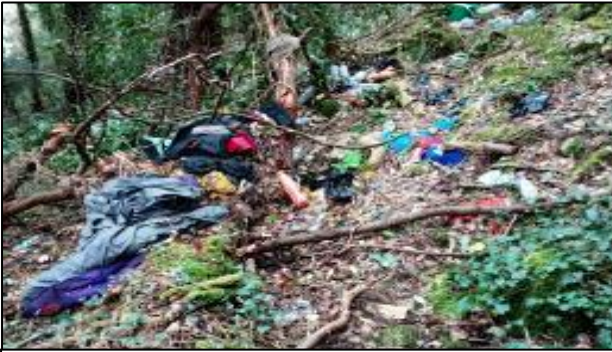
Most areas of littering and fly tipping are located away from main public access routes. 19 instances of extensive fly tipping were recorded, and 34 instances of littering.

Whilst the fly-tipping and littering have limited physical effects on the scheduled monument, they severely detract from the enjoyment and impact on experience of the hillfort.

Figure 31: Area of fly tipping on northern slopes

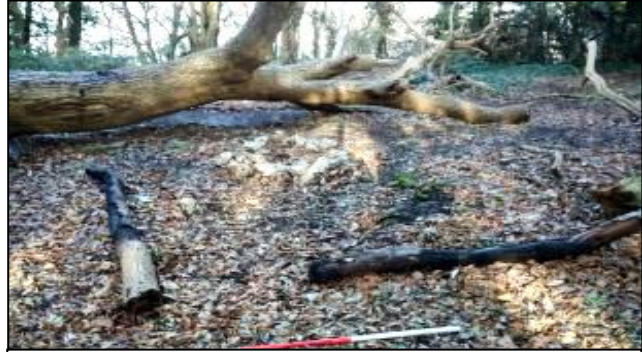
Figure 32: Large fire setting at top of Trinity Steps

Fire settings recorded in the condition survey were largely defined as causing ‘moderate damage’, and this was one of the most common instances of heritage crime recorded on the hillfort. 18 fire settings were identified during the condition survey. The majority of recorded fire settings are located along the southern ramparts, and incorporated removal of stone from the monument in order to create them.

The removal of stones leads to irreparable damage to the monument. As well as this physical effect, it impacts on the way in which visitors to the site experience the hillfort.

Signage to be erected to inform visitors of impact of damage	Signage to be installed		
	Objective	Detail	Method	Measure	Timing / Date	Who
1.9	Tackling illegal fires	Fire settings utilise stones from the hillfort itself, and cause damage to the underlying archaeology	Remove all fire settings under 5 year Scheduled Monument Consent (in line with method statement) Improve signage - notifying visitors of places within Weston Woods where they can use barbeques, etc. (see objective 2)	Eradication of fire settings within scheduled area	Ongoing	Volunteers
Objective 2: Increase awareness of the archaeological and historical importance of the site for the future, and to improve understanding and interpretation of the hillfort

3.5	Tackle illegal fires	Fire settings utilise stones from the hillfort itself, and cause damage to the underlying archaeology	Remove all fire settings under 5 year Scheduled Monument Consent (in line with method statement) Improve signage - notifying visitors of places within Weston Woods where they can use barbeques, etc. (<i>see objective 2</i>)	Eradication of fire settings within scheduled area	Ongoing	Volunteers
Objective 4: To involve the local community as fully practicable possible in the management of the hillfort

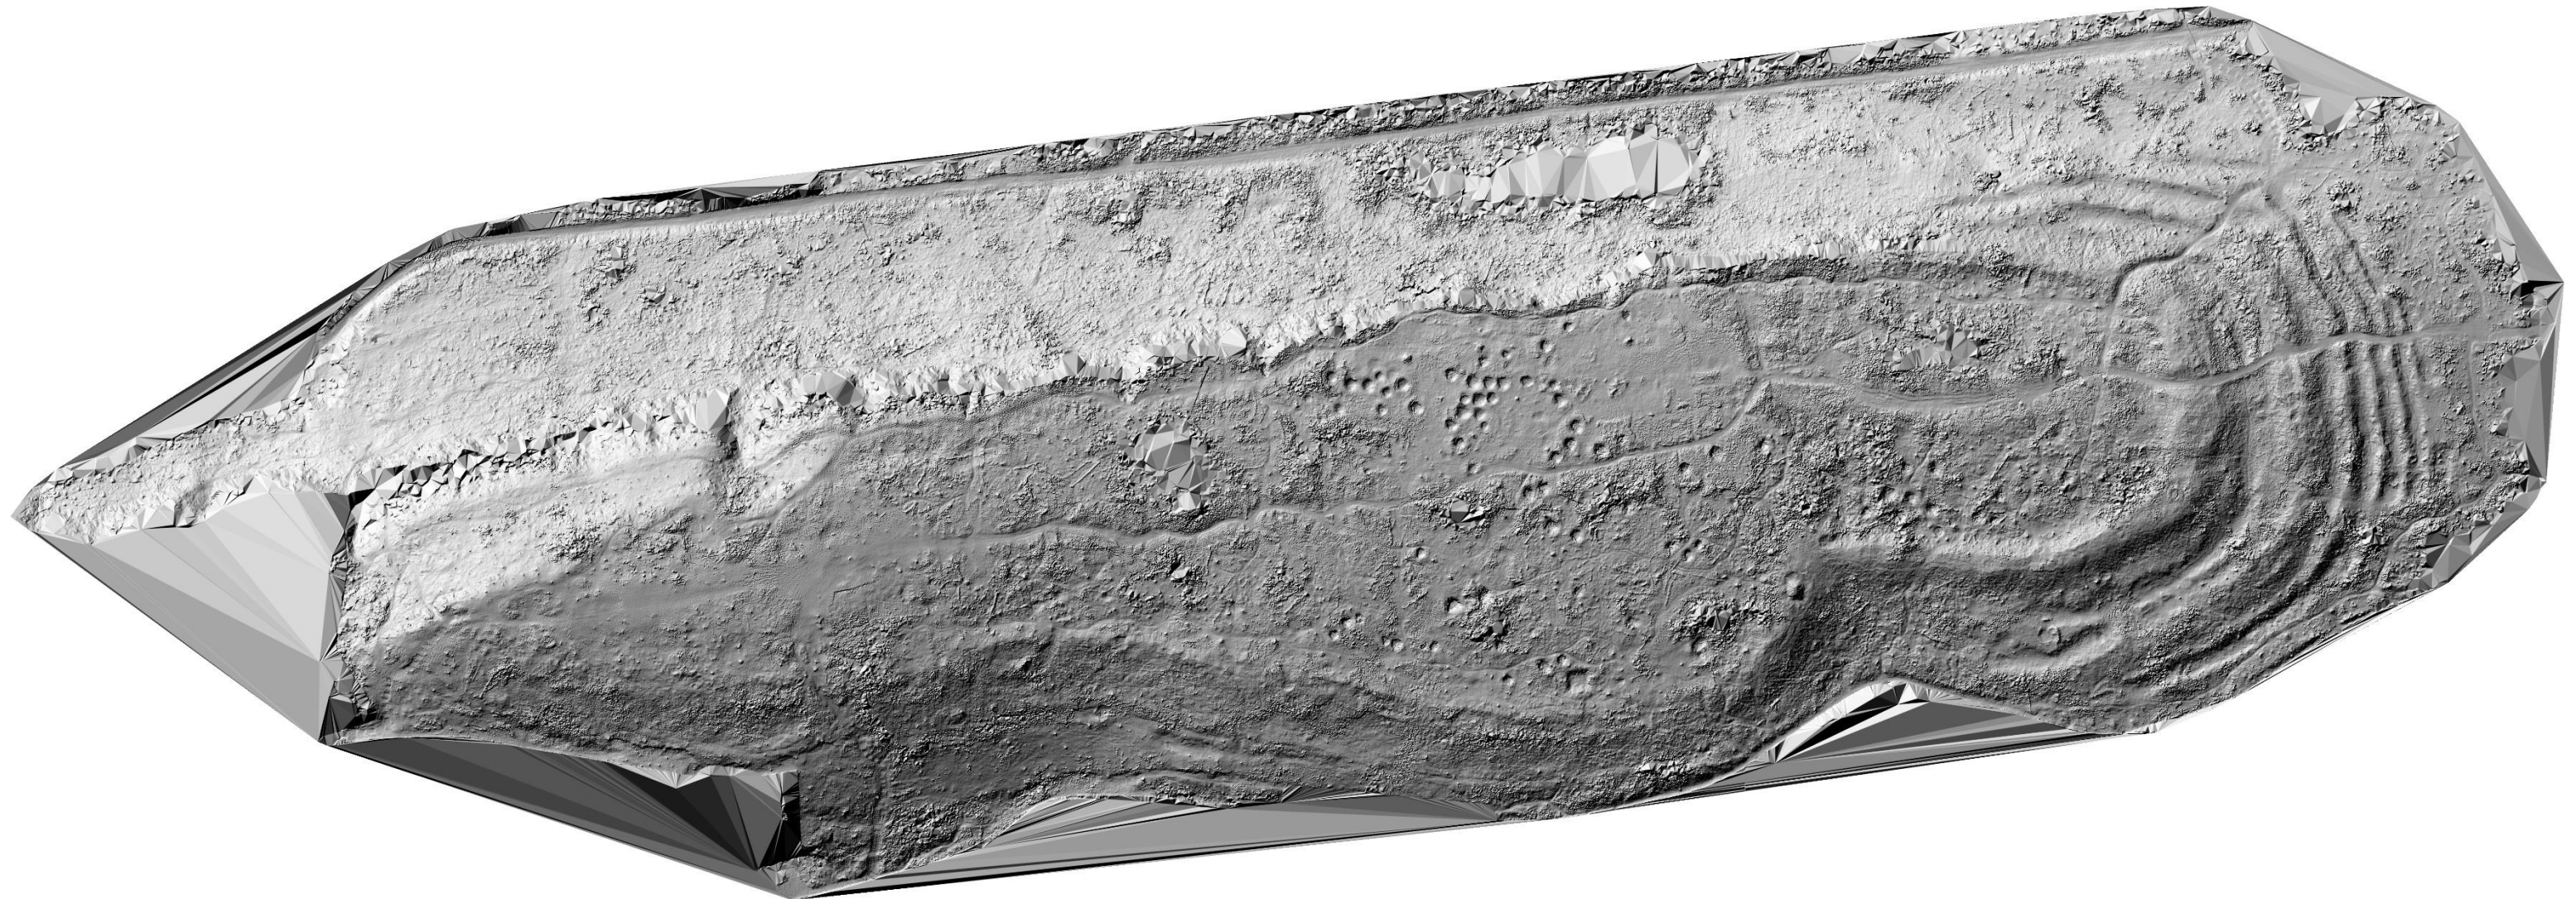
The topographical survey was carried out in January 2018 using a handheld laser scanner, with data collected across the full extent of the scheduled area. Surveyors from Cotswold Archaeology were able to record 43,200 points per second, with an anticipated accuracy of 2cm. The results of the digital terrain model can be found in figure 31.

Figure 33: Digital Terrain Model of Worlebury Camp (Cotswold Archaeology, 2018)

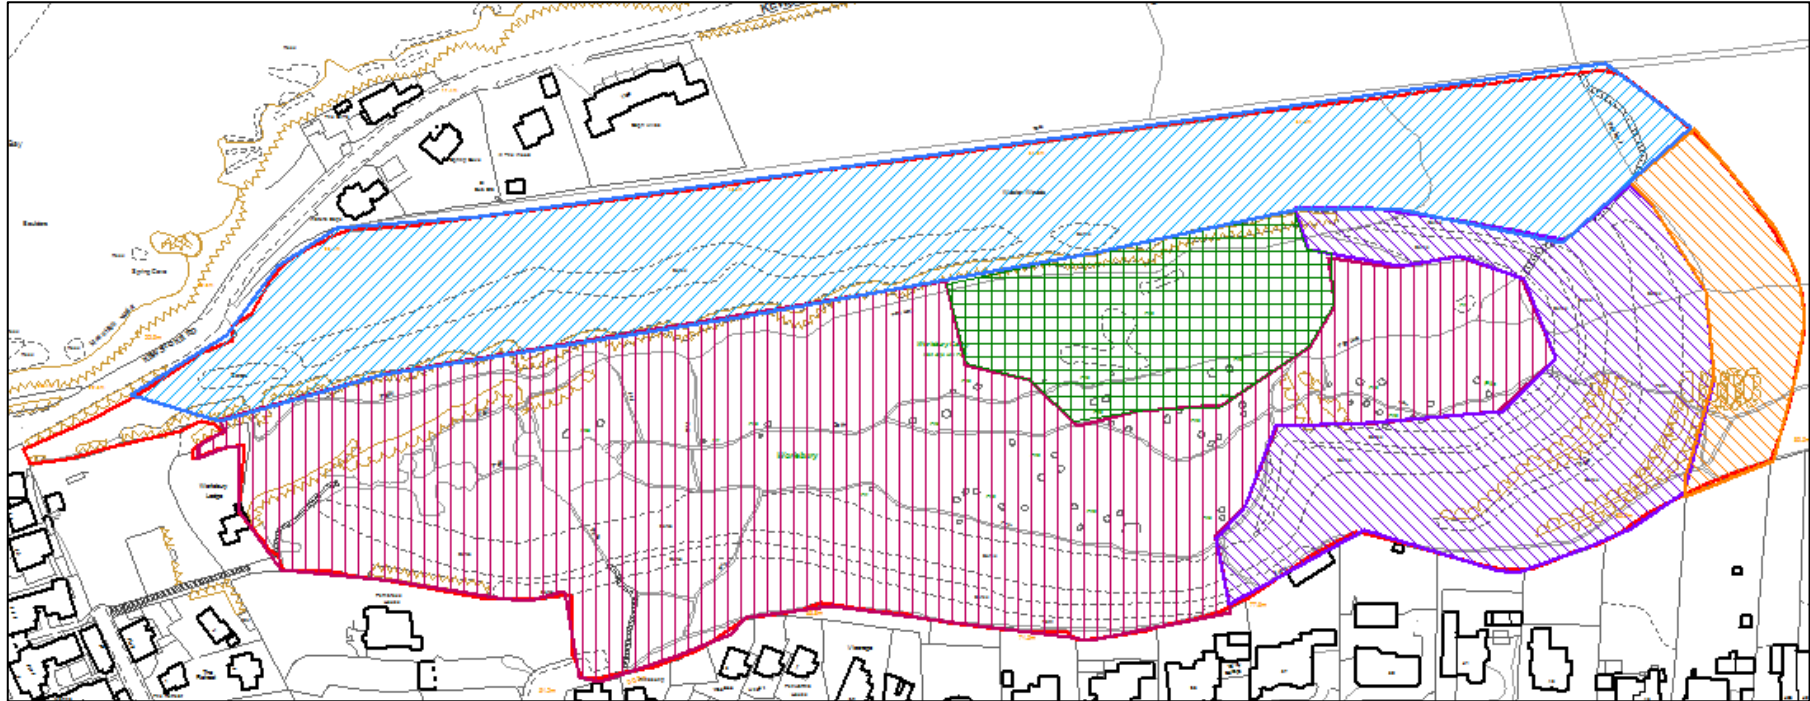
Figure 34: Areas identified for felling

All works should only be undertaken when weather and ground conditions are suitable (i.e. the ground surface must not be broken or disturbed).

Due notice of archaeological earthworks or other historical features should be taken when felling larger trees and boughs, and measures should be taken to ensure that damage is not caused by falling timber.
