**Land at Rectory Farm  
(North), Yatton, North  
Somerset**

**Heritage Statement**

Prepared by:  
**The Environmental Dimension  
Partnership Ltd**

Report Reference  
**edp7842\_r002d**

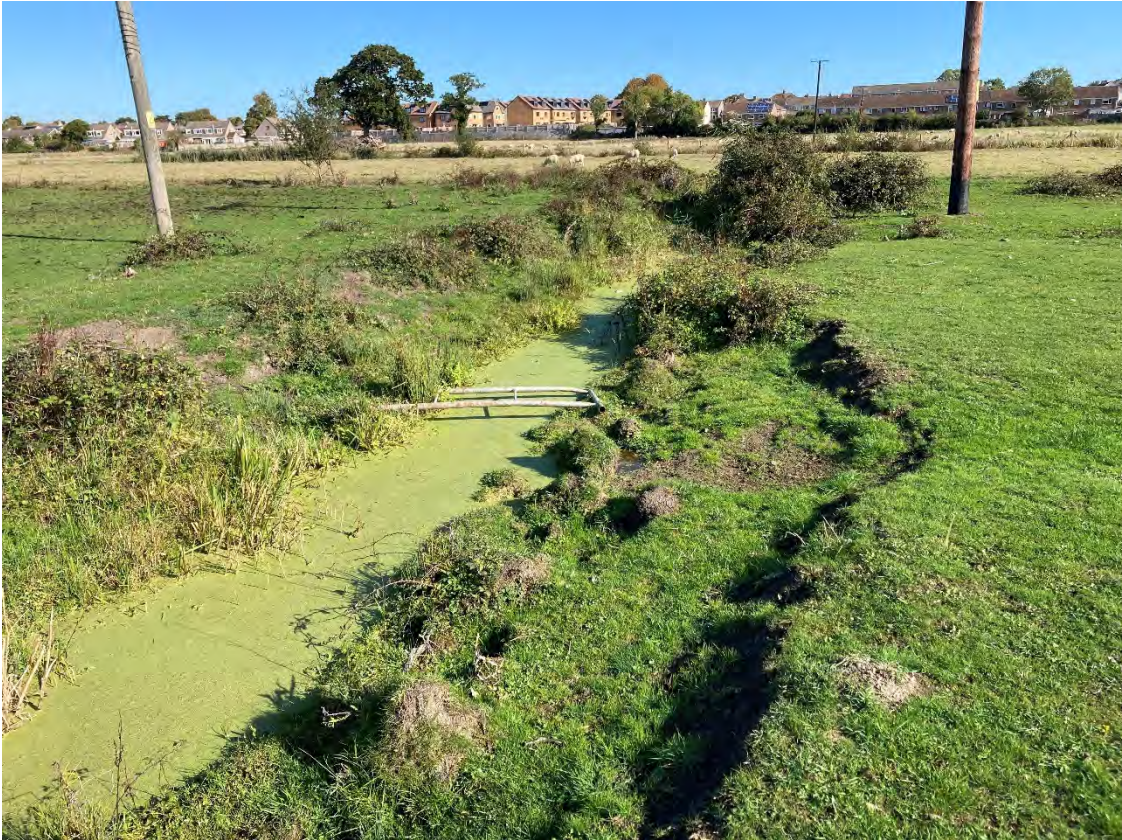
**Image EDP 1.1:** View across part of the western fields at the Site, illustrating how they are divided by drainage ditches (rhynes), part of a wider system of land drainage on the North Somerset Levels.

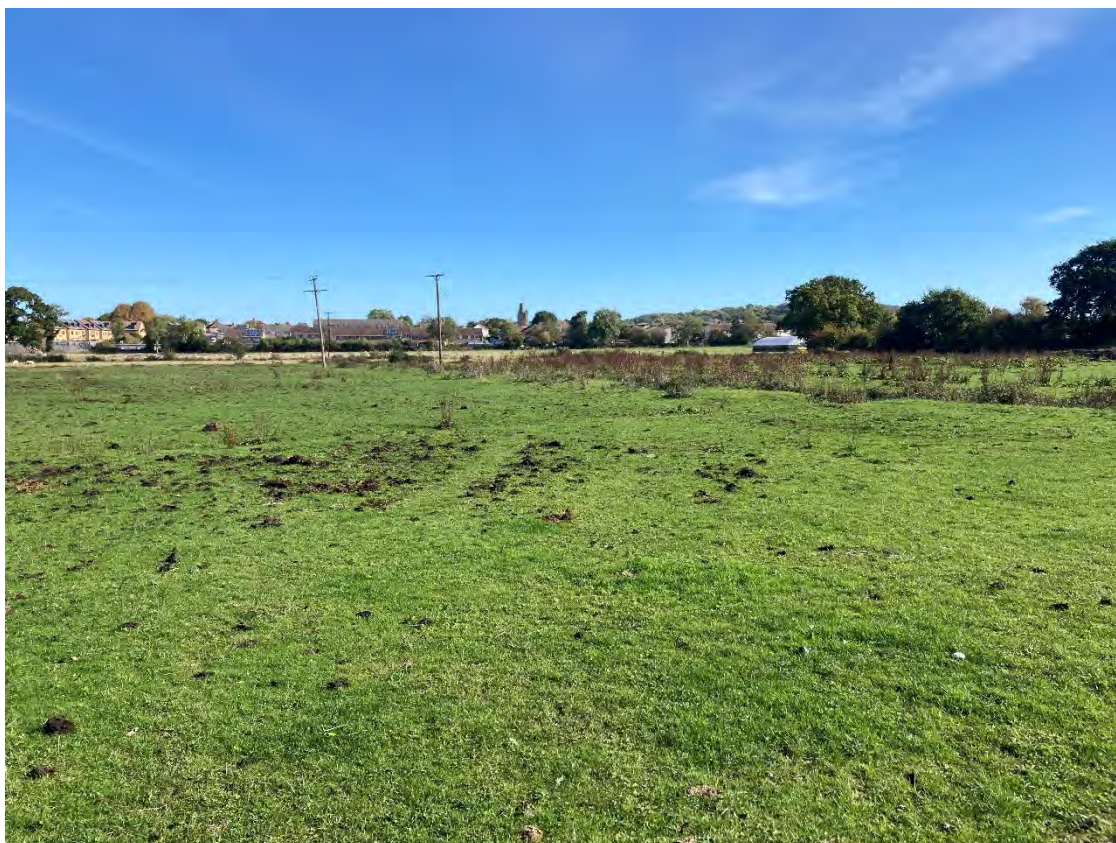
**Image EDP 4.3:** View across the western part of the Site to the church tower, illustrating its general prominence in views from across much of the Site.

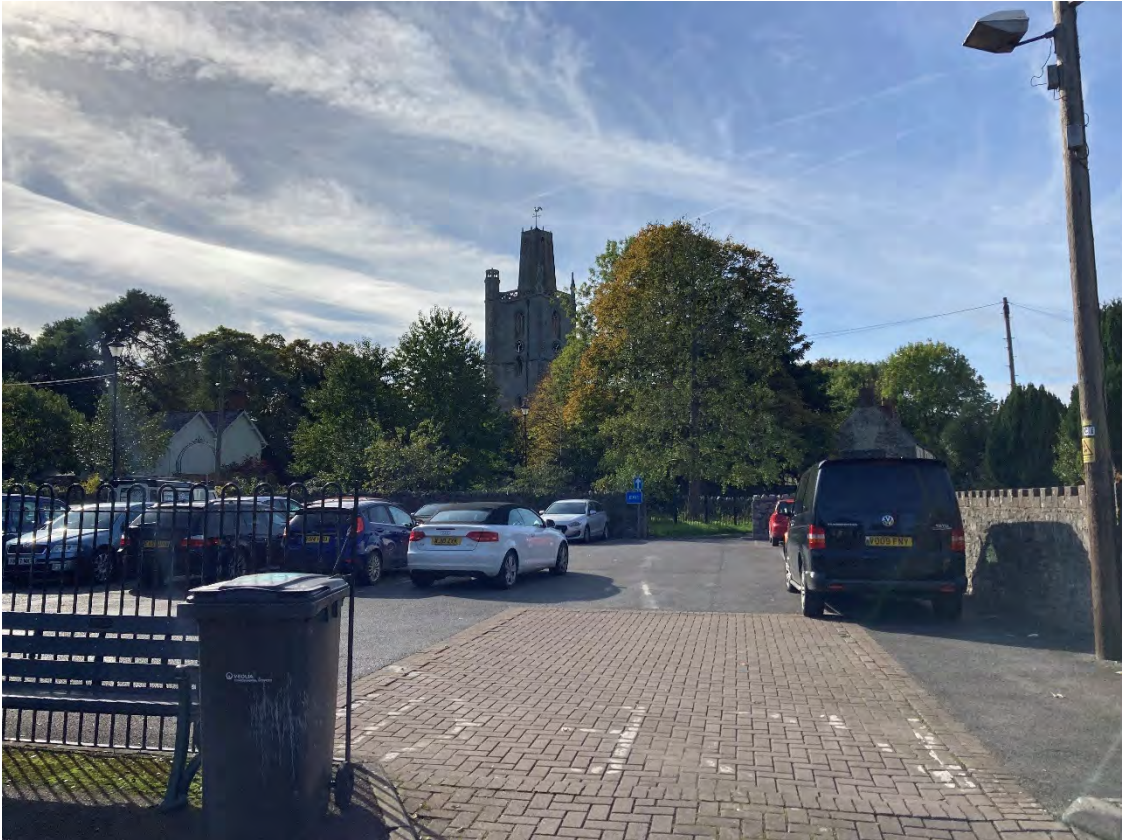
**Image EDP 4.5:** View across part of Yatton’s centre, illustrating how the church tower is a locally prominent feature of the village.

- 4.25 The church is especially prominent in views to the south-west along Church Street as it is approached, but it is also visible from many locations in the historic core as a prominent building on account of its height (**Image EDP 4.5**).

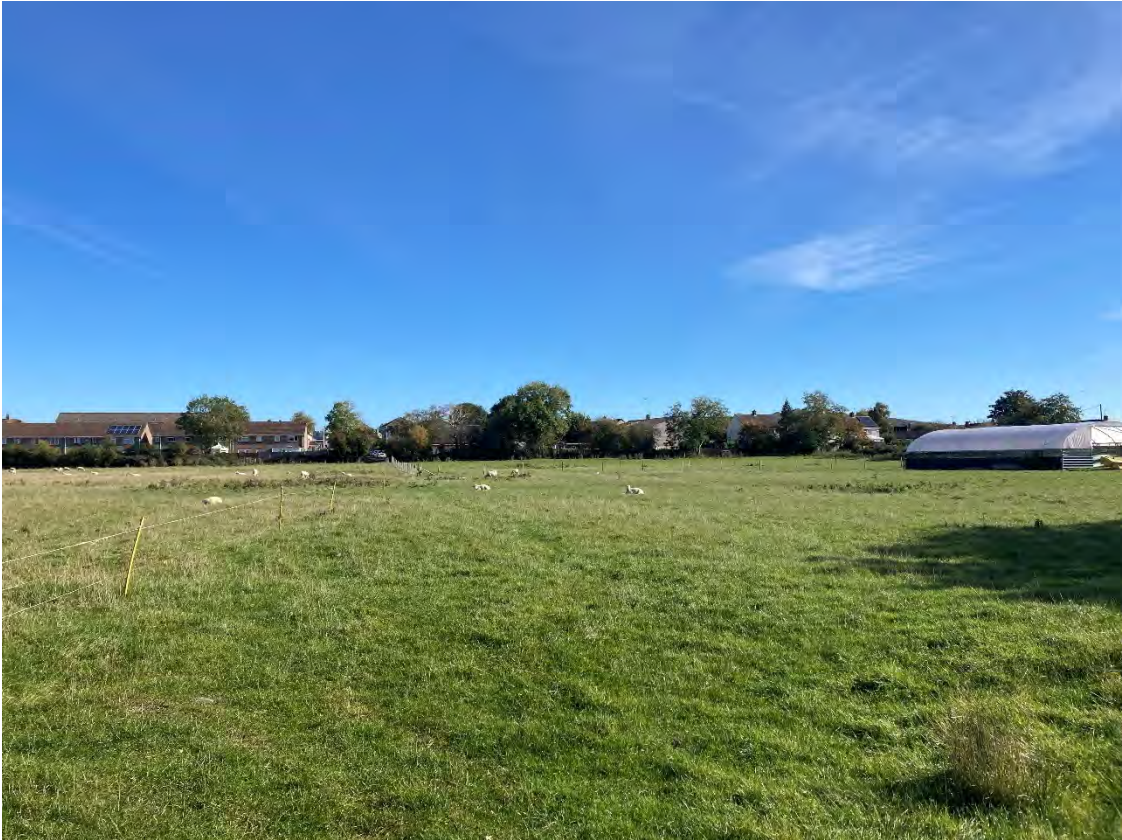
**Image EDP 4.6:** View towards the church from the south-eastern part of the Site, illustrating how its tower becomes less visible in the nearer, eastern areas due to screening by intervening trees and buildings.

- 4.29 In other words, the ability to see a church tower does not necessarily mean that the location from where a view is possible, makes a contribution to the church’s significance, and similarly, the loss of these views does not necessarily result in an impact. Whilst the church was evidently designed to be seen from afar, the view to the church tower from the Site is entirely incidental and on account of the size of the building rather than due to a designed view intended to be had from this specific location. A similar view can be achieved from many locations in the wider landscape.

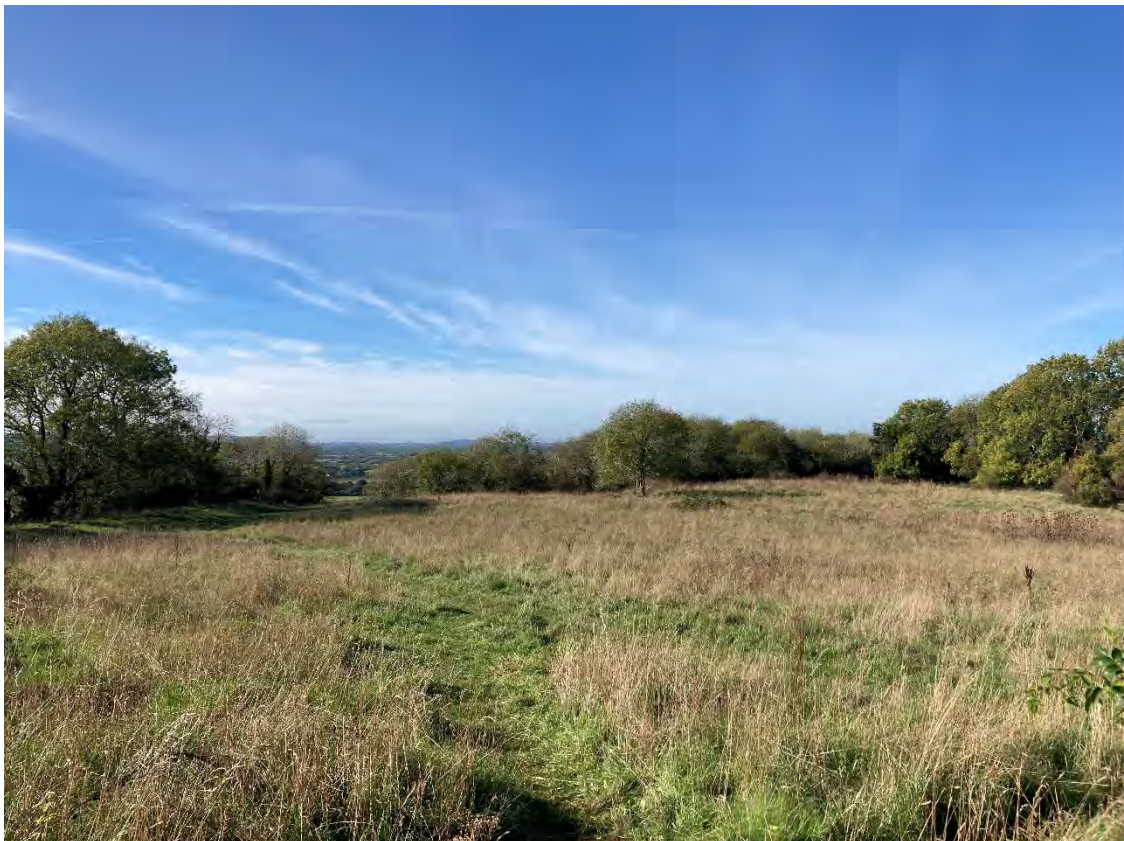
**Image EDP 4.7:** View across the western part of the Cadbury Hill fort, illustrating how it is enclosed by trees with only glimpsed views through gaps to the wider landscape possible.

- 4.38 Likewise, views out from the scheduled monument comprise glimpses through gaps in the vegetation (**Image EDP 4.7**) and only a limited perspective is possible of the surrounding landscape. Nonetheless, its hilltop position is appreciable, and its topographic situation is a key aspect of its setting that contributes highly to its significance.

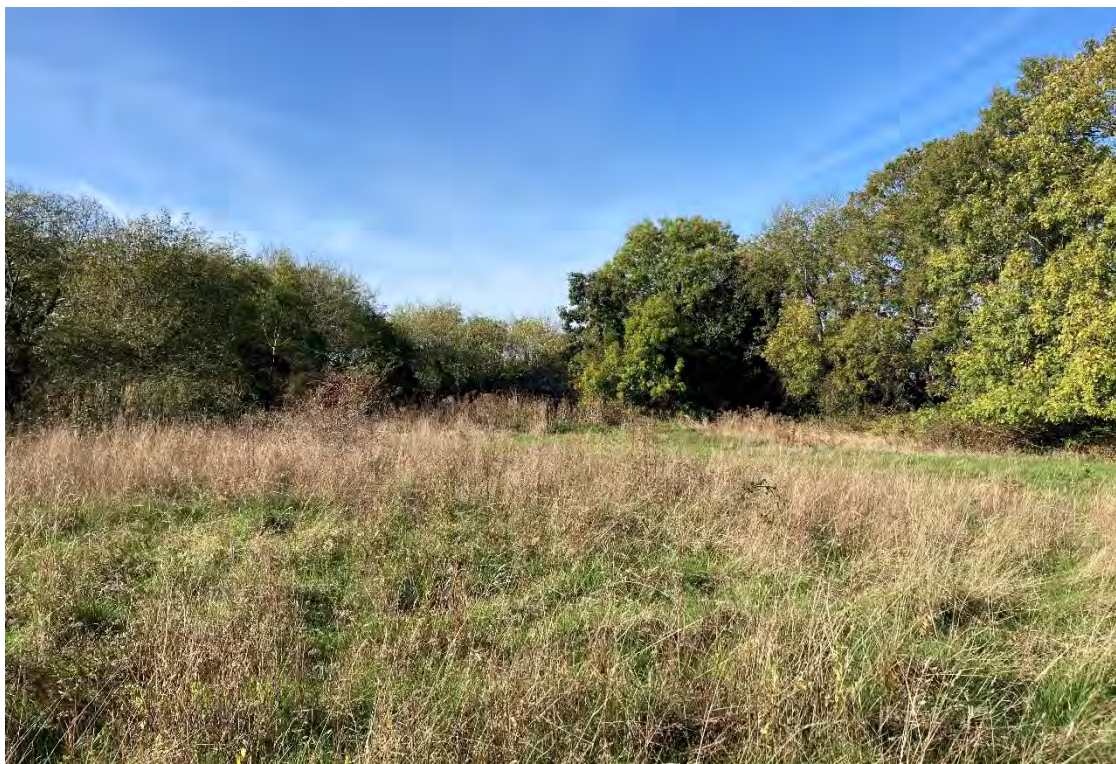
**Image EDP 4.8:** View directly towards the Site from Cadbury Hill fort, illustrating how the view is screened by woodland.

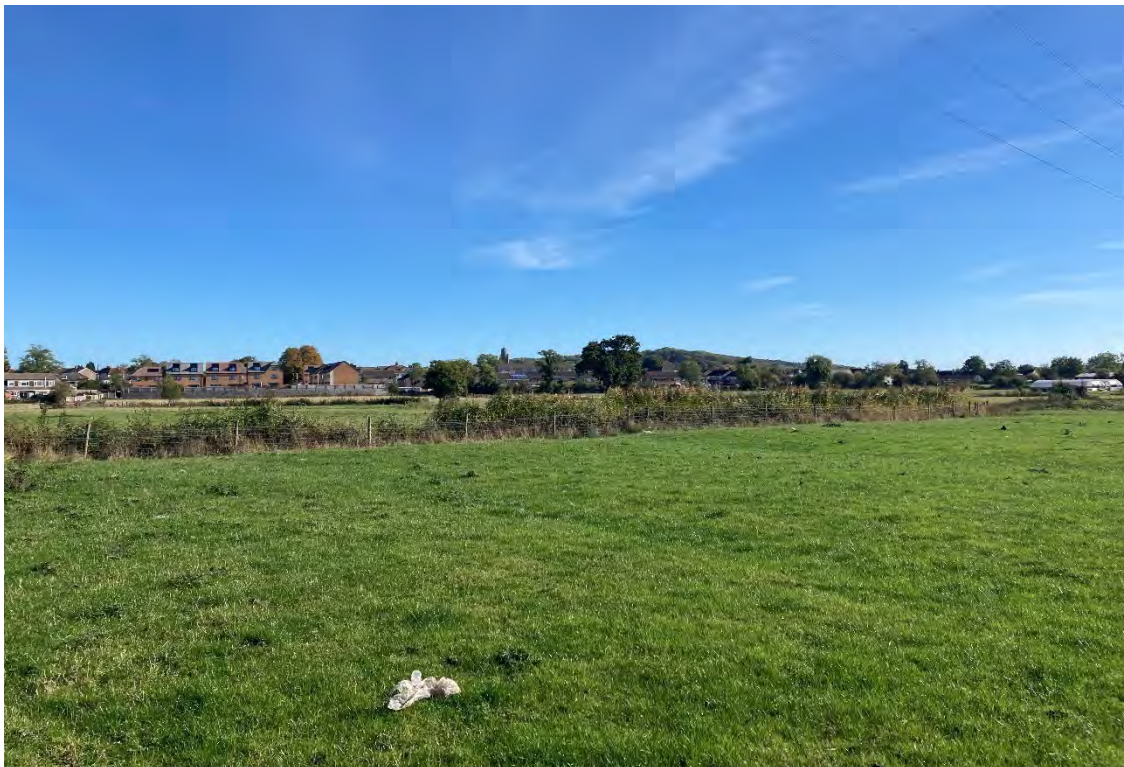
**Image EDP 4.9:** View towards Cadbury Hill from the Site (with the church tower also visible) illustrating how the monument is indistinct and experienced from the Site as a wooded hilltop.

- 4.41 With regard to the ‘experience’ from the Site (**Image EDP 4.9**), whilst the hilltop where the monument is located can be seen, it is only experienced as an area of woodland and the monument’s earthworks cannot be understood or appreciated; it is not possible to make out that it is an archaeological earthwork feature. Due to the lack of any visual connection and, due to there being no historical or functional association between the land at the Site and the monument, it is concluded that the land at the Site does not form a part of the monument’s setting that makes a contribution to its significance.

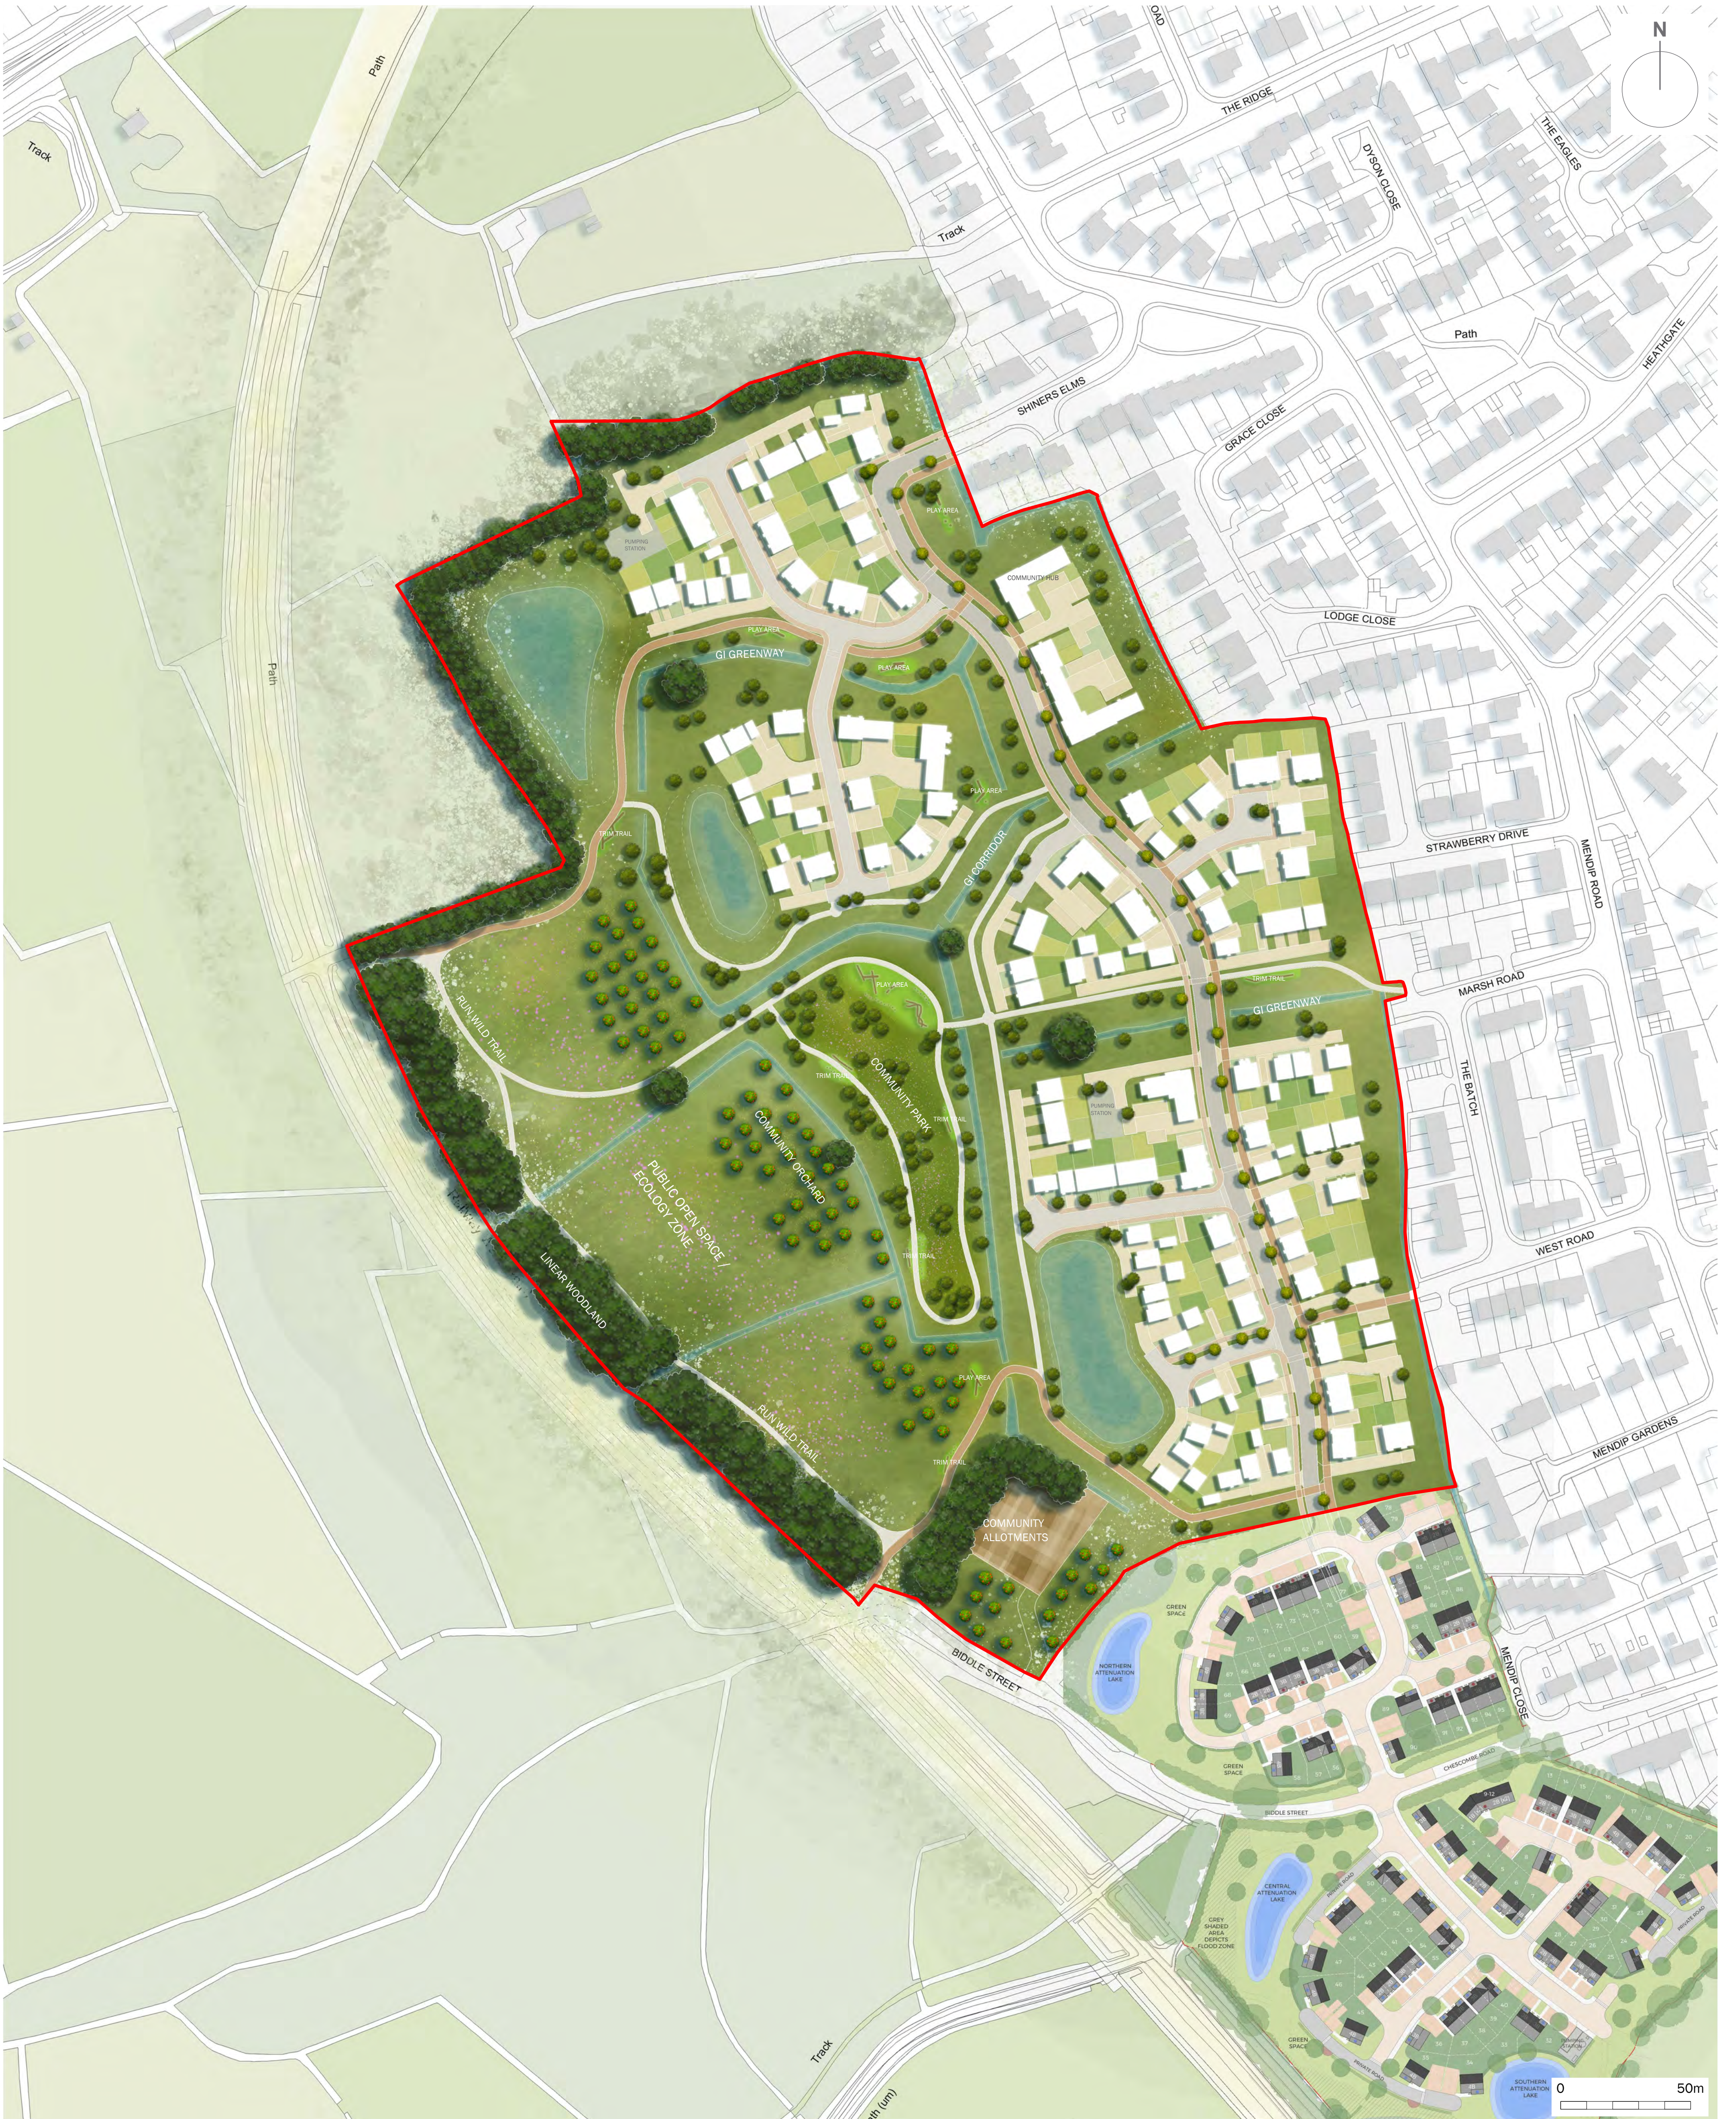
## Illustrative Masterplan

- date 14 MARCH 2023 - drawing number edp7842\_d003g - scale 1:1,250 @ A1 - drawn by OSh - checked GHo - QA PDA

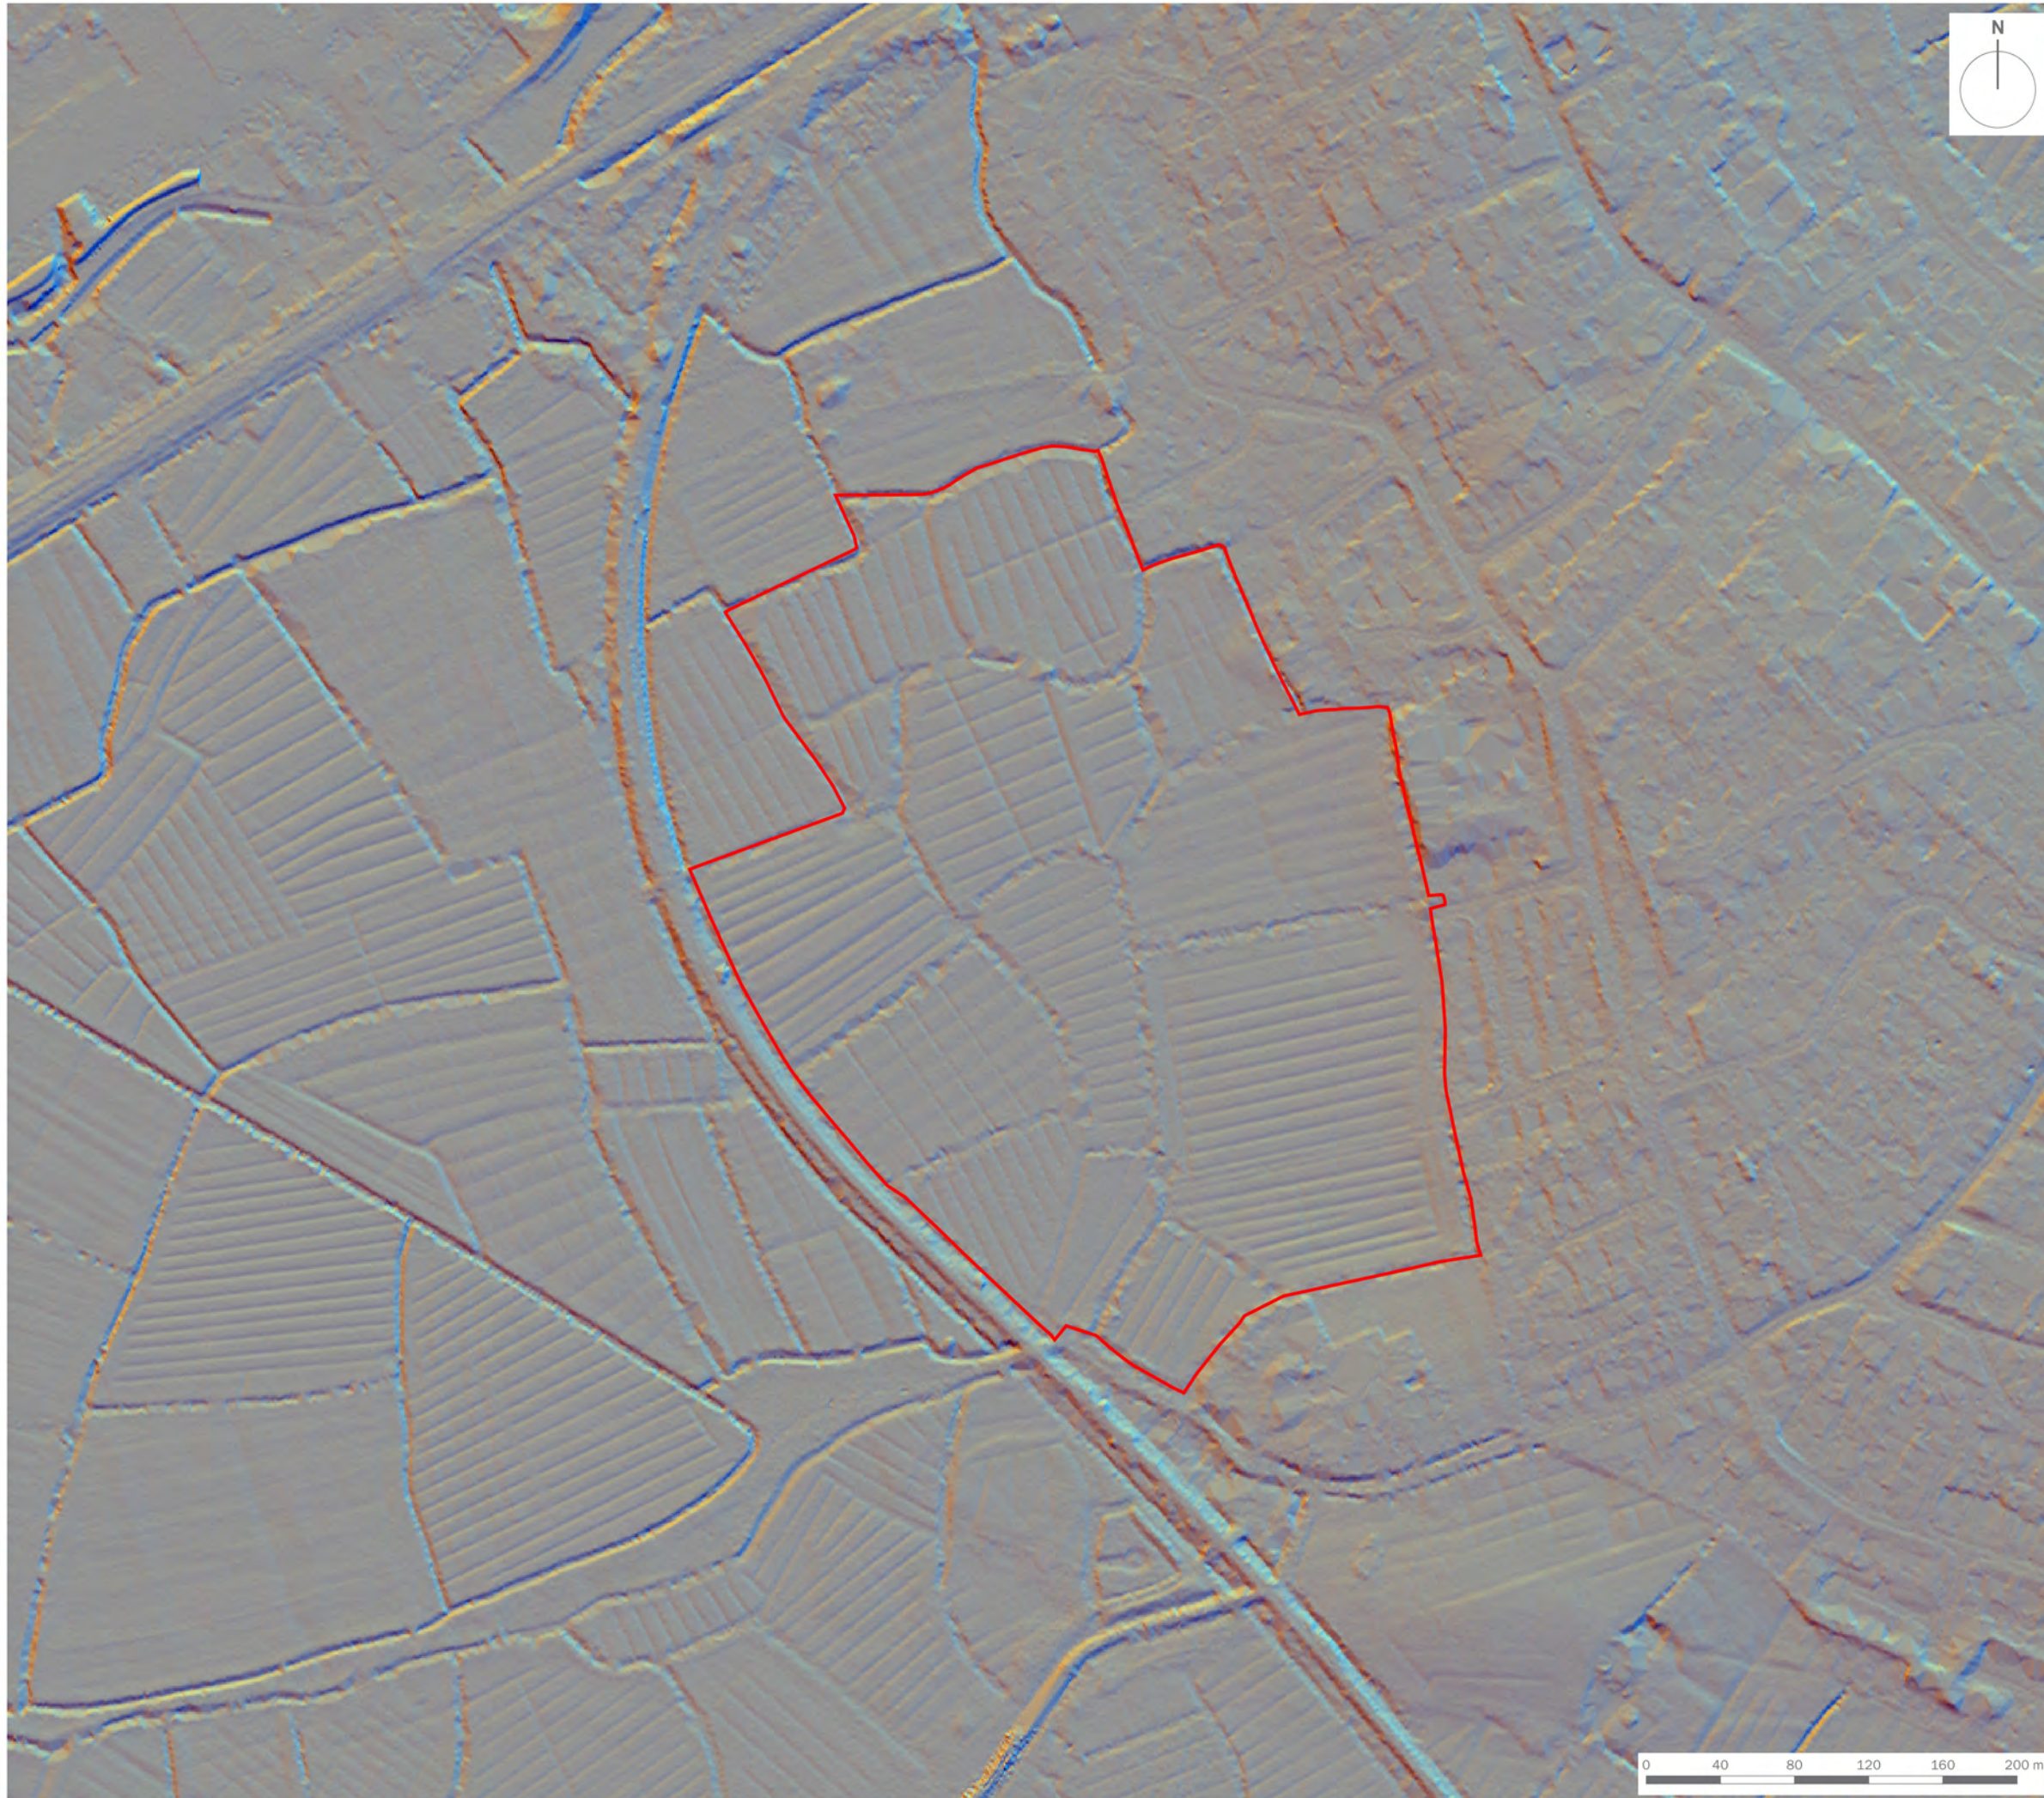
- Site Boundary
- LiDAR Data Using 1m Digital Terrain Model (DTM) Using Multi-directional Azimuth Shading
