# Pineapple Farm

Lighting Impact Assessment –  
Lighting Baseline

PROJECT No. 4206

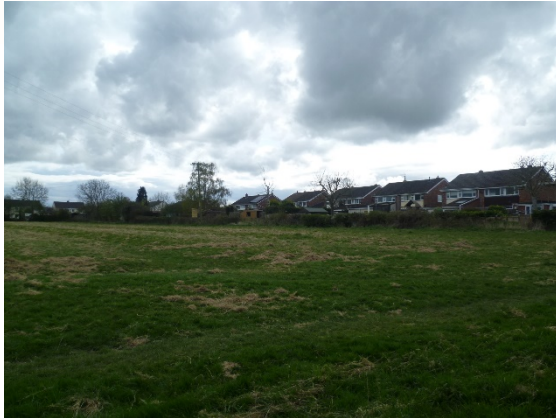
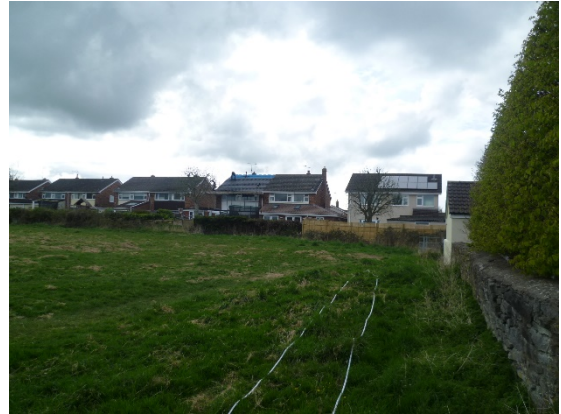
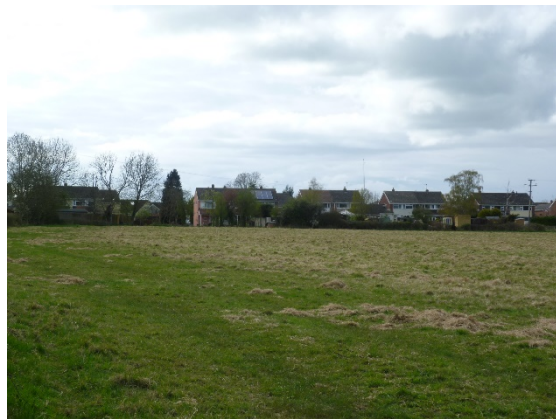
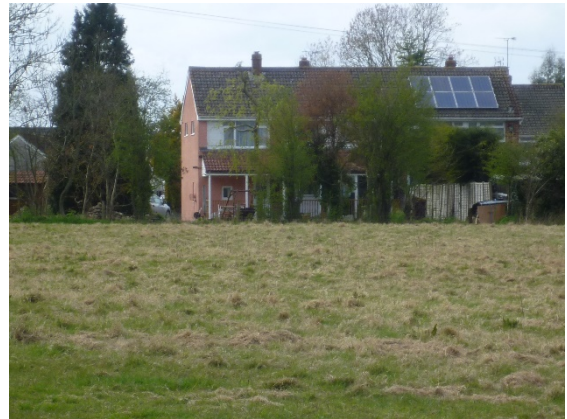
The back gardens of residential properties bound the site to the west, south and north west with varying boundary treatments. The heights and nature of the boundary treatments vary widely, with some sections of boundary vegetation along the southern and western boundaries having been cut back or removed. A number of the neighbouring properties have various types of lighting to their rear elevations including security style floodlighting and wall mounted amenity lighting, most of which was not operational at time of the survey.

Figures 3.1 – 3.4 – show the western boundary of the site with the neighbouring residential properties, and varying boundary treatments, including sections where there is minimal boundary vegetation or screening.

Depending on the locations of any proposed dark ecological corridors associated with the proposed development, consideration should be given to enhancing the boundary vegetation/screening in areas where it has been reduced or removed, to ensure the dark corridors can be maintained.

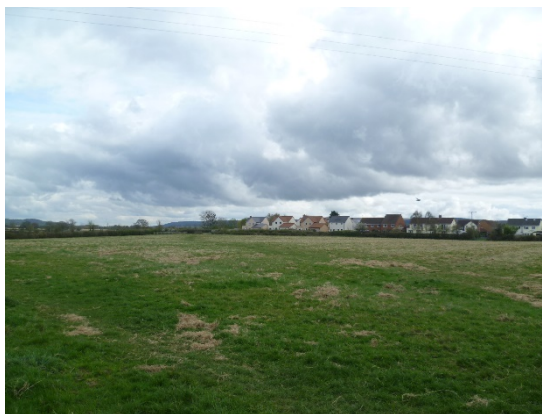
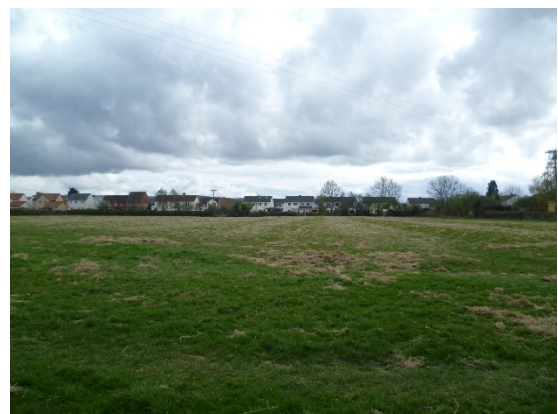
Generally, the neighbouring properties are well set back from the site boundary, with approximately 10-30m long gardens which offset the buildings. The houses to the east of Mulberry Road, and to the north of Venus Street, that abut the southern boundary of the site have a wider and taller section of vegetation than the rest of this southern boundary which screens light spill from those properties to the site.

Figures 3.5 and 3.6 - show the southern site boundary with neighbouring residential properties

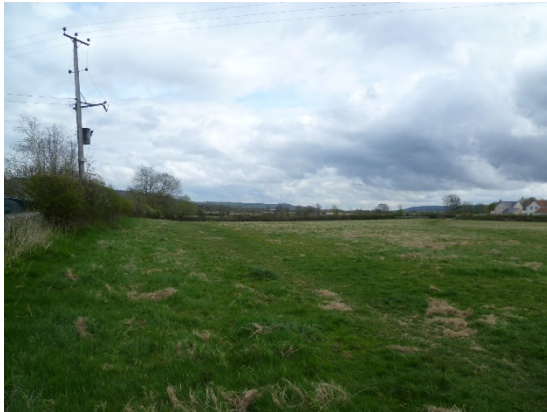
Figure 3.7 – shows the eastern boundary of the site, an eastern section of the northern boundary.

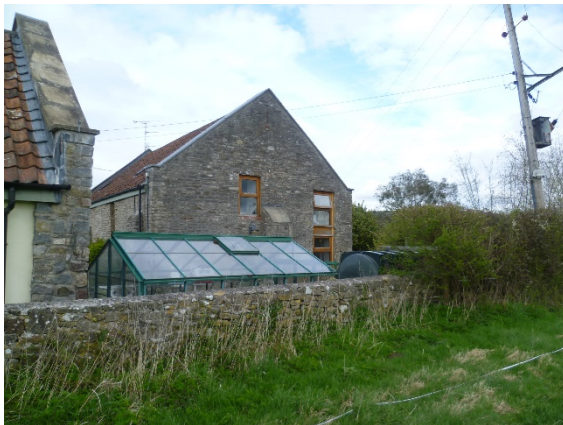
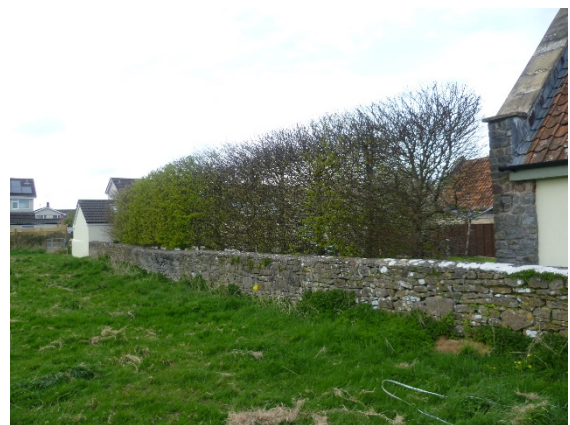
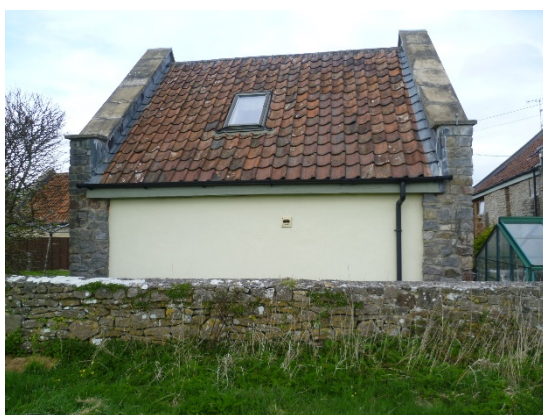
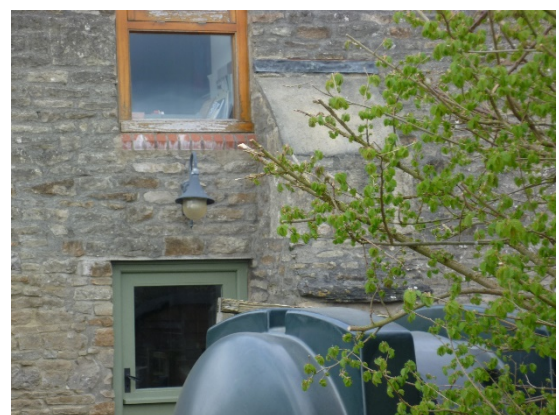
Figures 3.8 – 3.11 – show the residential property to the north of the site, along the western section of the site boundary. This property is relatively close to the site boundary with external lighting present, and limited boundary vegetation.

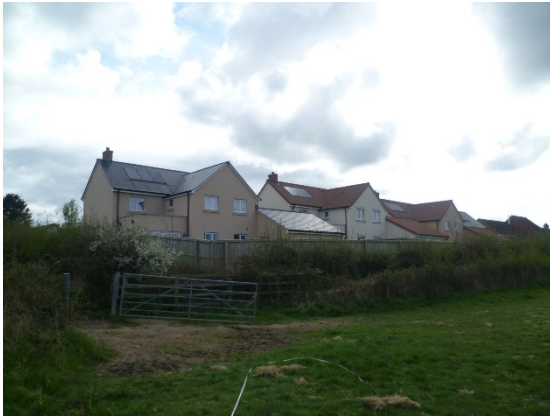
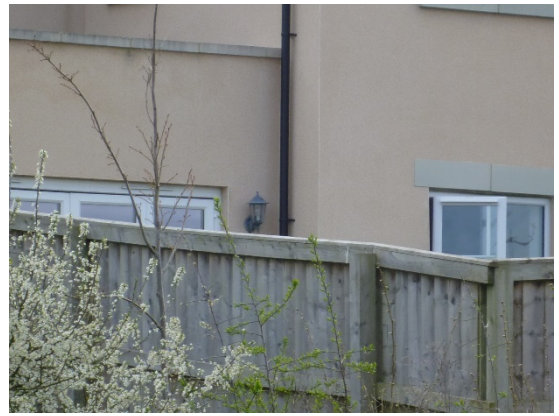
Figures 3.12 and 3.14 – show the eastern section of the southern boundary with an example of the type of wall mounted lighting that is present to the neighbouring residential properties.

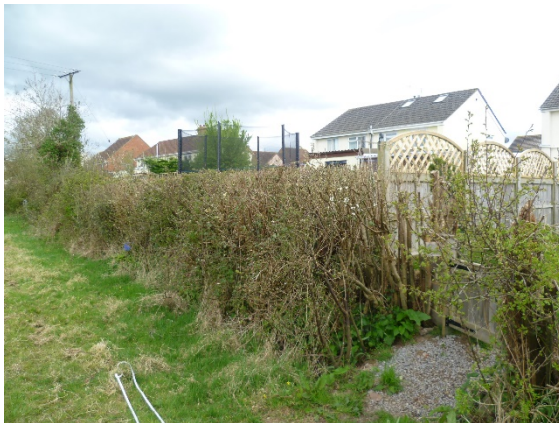
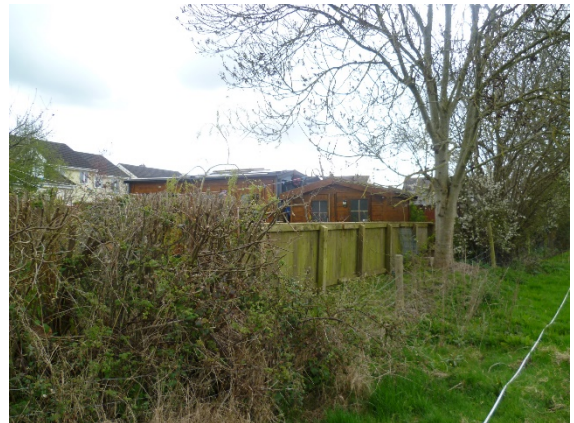
Figures 3.15 and 3.16 - show the western section of the southern boundary, showing an example of where the boundary vegetation has been cut back.

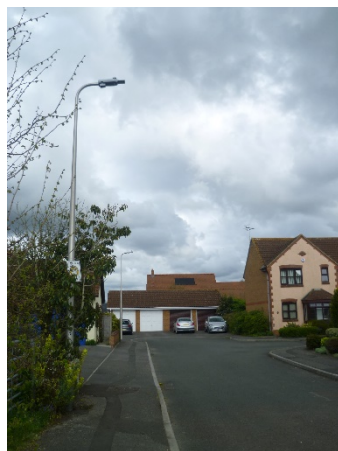
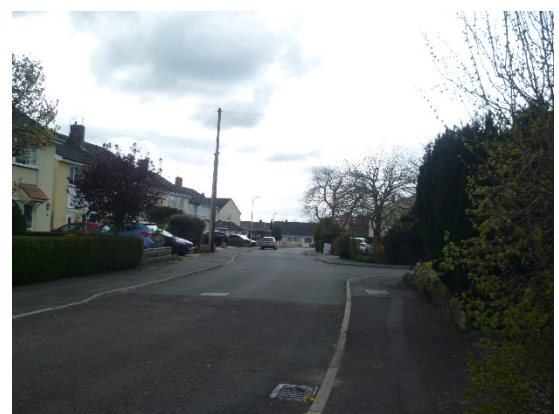
There is 4000K LED street lighting along Mulberry Road and Park Road. One of the street lights in Mulberry Road is directly next to the site access point.

The measurements recorded show that the site and site boundaries are dark, except for the area where the access lane abuts Mulberry Road. Levels of illuminance  $\geq 0.5$  lux extend approximately 7m into the access lane from the site access point along Mulberry Road. The maximum level of illuminance recorded at the boundaries of the rest of the site was 0.02 lux.

Figures 3.17 and 3.18 – show the 4000K LED street lighting in Mulberry Road, which is also the same type of street lighting as to Park Road.

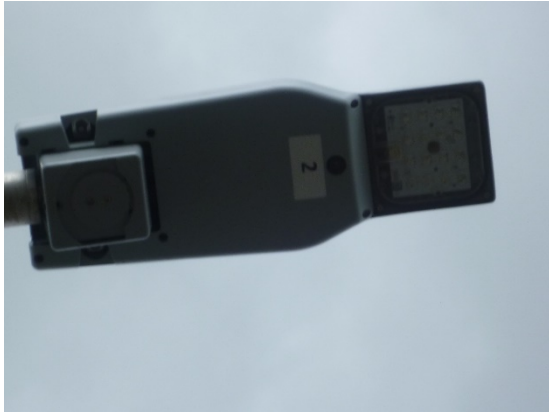
Figure 3.19 – shows a close up of one of the LED street lights in Mulberry Road.
