TB/280224/HS/8280

Thank you for the response received in relation to Land North of Rectory Farm, Yatton; planning ref: 23/P/0664/OUT. I was pleased to see that you have had the chance to review the report and wanted to provide clarifications on some of the points raised.

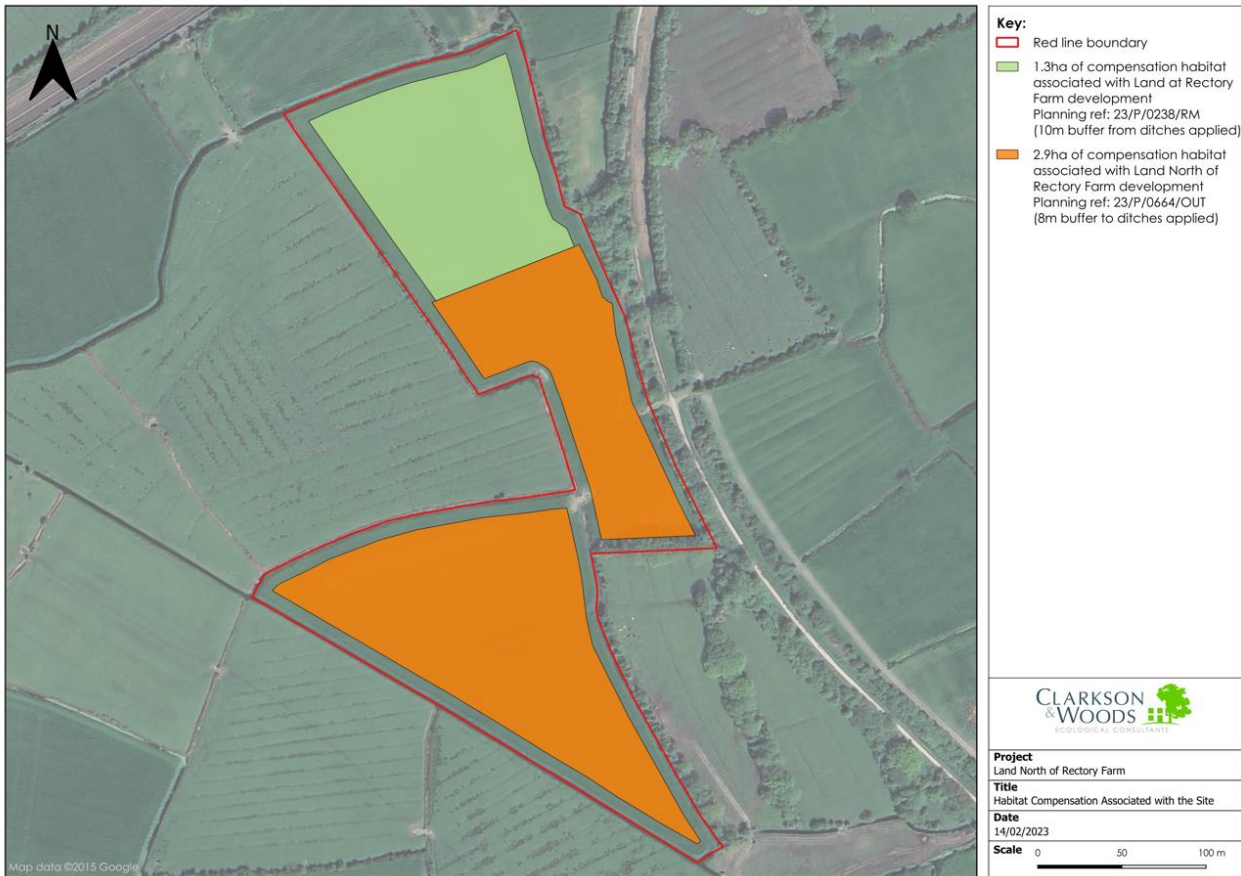
I have provided a figure with the area shown as compensation habitat associated with Land at Rectory Farm 21/P/0236/OUT marked along with the remaining 2.9ha of which is earmarked for compensation habitat associated with the Land North of Rectory Farm proposals 23/P/0664/OUT. This is provided in a revised Shadow HRA (Figure 9) and reproduced below. This includes an eight meter offset from the bank tops of all ditches land within which is not included in the HEP calculation totals. This is a slight reduction in the ten meters originally proposed but is more than the 5m riparian buffer zone put forward in the BNG methodology for the protection of ditches¹. It is considered an adequate buffer to protect the ditches from impacts from the restoration of the grassland. No scrub or trees are proposed for inclusion within ten meters of any ditch to prevent shading and to allow ongoing management by the IDB.
